FACILITY ANALYSIS

VILLA PARK PUBLIC LIBRARY

Final Report

March 4, 2015

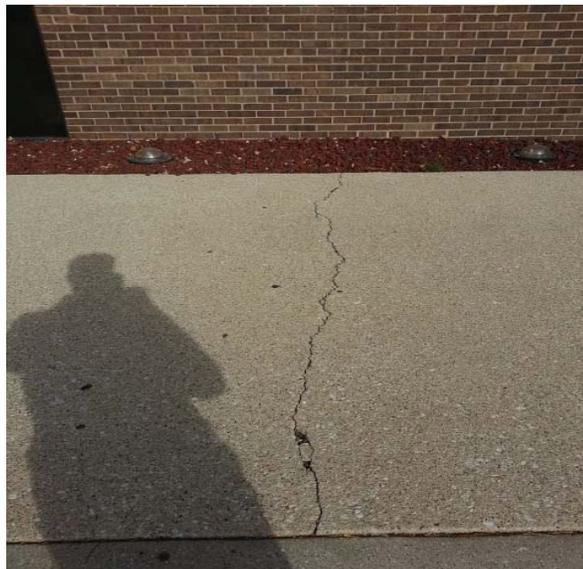
6. A French drain was installed just east of the eastern property line to capture any flow coming from the Library property to the Church property.
7. Cracking in the sidewalk south of the Library is evident in multiple places. This cracking would appear to be due to settlement.

Example of sidewalk cracking

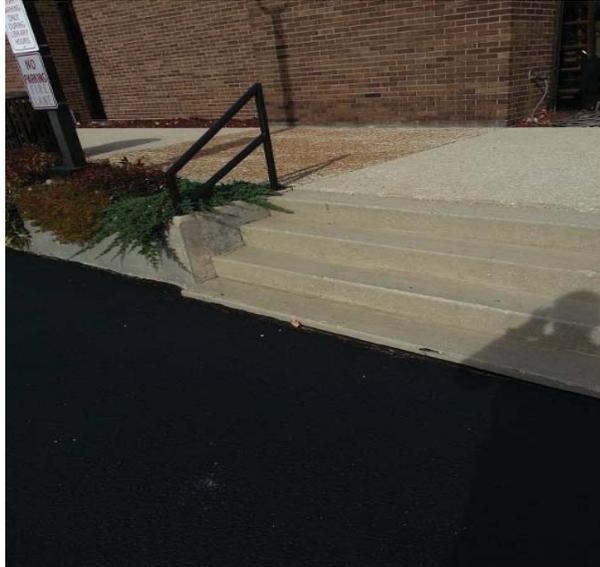
15. There is noticeable cracking in the stairway outside the southeast corner of the building. This cracking would appear to be due to settlement.

Cracking in stair; refer to left wing wall

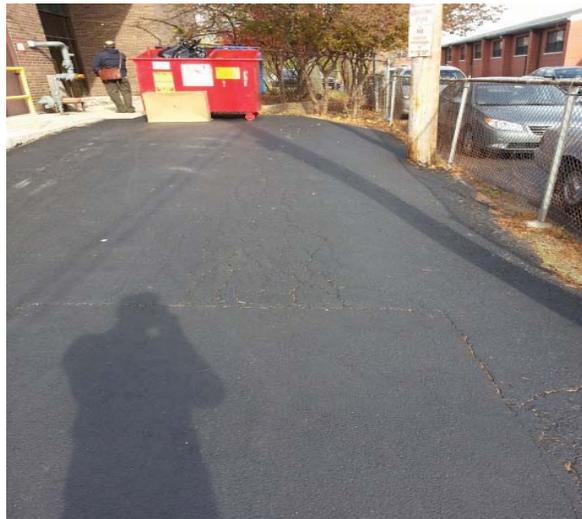
16. There is a significant grade difference in the pavement area reserved for trash collection located near the southeast corner of the building. The pavement generally slopes from west to east with a significant drop of about 18" in the last 10' before the property line.

Slope of pavement

There is a significant elevation change in the garbage collection area. The existing slope/grade may be a safety issue in terms of the public traversing via foot or it may be an traffic issue should a vehicle utilize the area for some type of vehicular movement. It would be EEA's recommendation to renovate the area for better utilization and safety precautions. This would involve performing a topographic survey, analyzing the data, and having a civil engineer design a solution. The solution most likely would involve installation of retaining wall, re-grading/sloping the area, and re-paving the area.

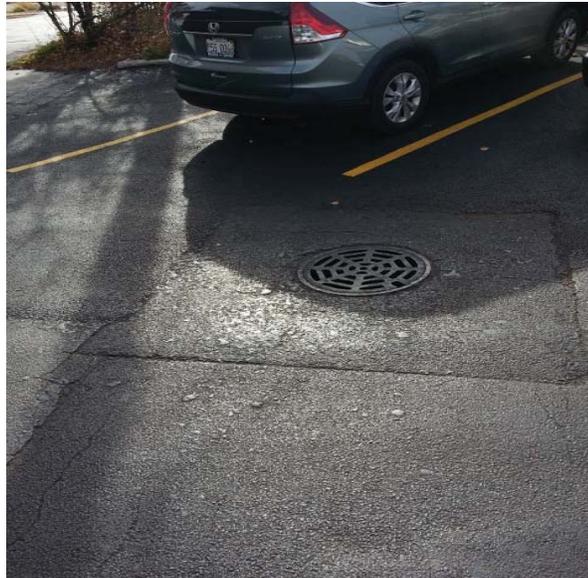
18. The patch around the storm manhole discussed in Background Information 4.C. does not appear to have settled significantly since the patch was applied.

Patch around storm manhole

Due to the past settlement issue around the existing storm structure discussed above, EEA would recommend monitoring the area closely. Based on the previous issue, the subject area would be considered to be more likely for a potential settlement issue. The reconstruction completed previously appears to have worked and does not appear to require additional maintenance at this point.

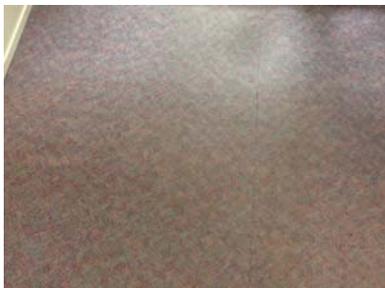
The carpet tile flooring is showing sign of wear in high traffic areas; discoloration from exposure to light; and staining. The carpets throughout are nearing the end of their serviceable life.

Figure 1. Wear pattern visible adjacent to door from stair @ 1st floor

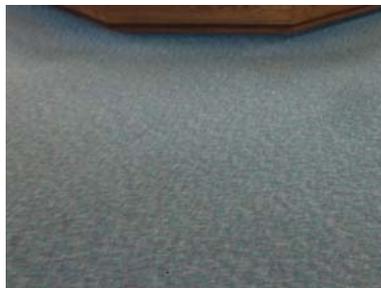
Figure 2. Discoloration visible adjacent to Circulation Desk @ 1st floor

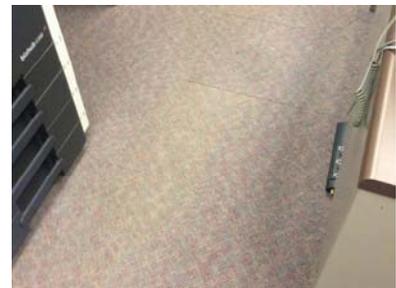
Figure 3. Wear pattern visible @ 1st floor office area

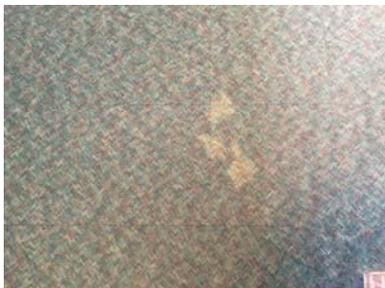
Figure 4. Straining visible at 2nd floor Lobby

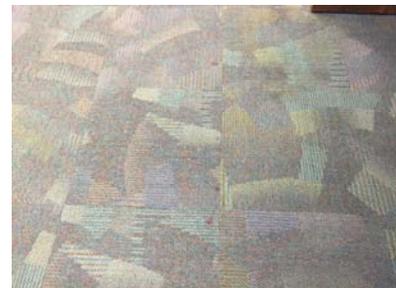
Figure 6. Fading and staining visible at 2nd floor Story Room.

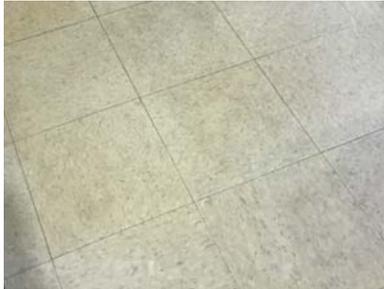
The condition of the vinyl tile flooring is in fair condition; however, based on the 1968 drawing set, the original vinyl was made with asbestos or vinyl asbestos tile (VAT). If modifications are made to the flooring in these areas the tiles will either need to be encapsulated or abated and replaced.

Figure 7. Discoloration/dirt @ 2nd floor staff restroom

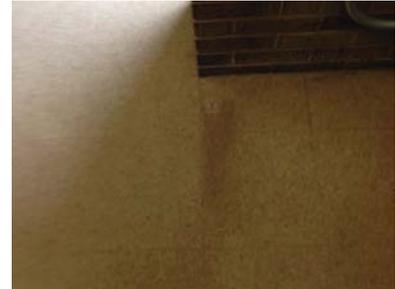
Figure 9. Staining visible @ 1st floor stacks area

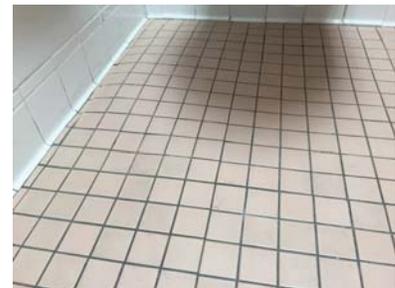
The condition of the ceramic floor tile inside the public restrooms at the second floor is in poor condition. The mesh-backed mosaic 2x2 tiles appear to be delaminating from the substrate within the Girls's Toilet Room and is likely caused by water leaking from the adjacent plumbing fixtures. Additional concerns include darkened grout, wearing, and cracking at select locations due to traffic, use, and abuse.

Figure 15. Delaminated and cracked tiling at Women's Toilet Room

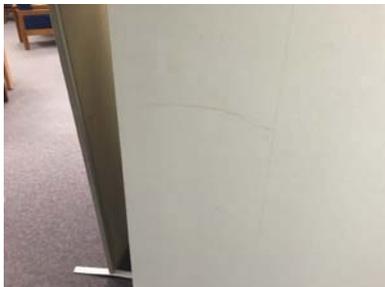
The condition of the wall coverings throughout the facility is in poor condition. The vinyl coverings are damaged, torn, or marked beyond repair throughout. The sheet carpet wall coverings also have damaged and stained surfaces. Both types of wall coverings throughout are nearing the end of their serviceable life.

Figure 19. Damage @ 2nd floor corridor

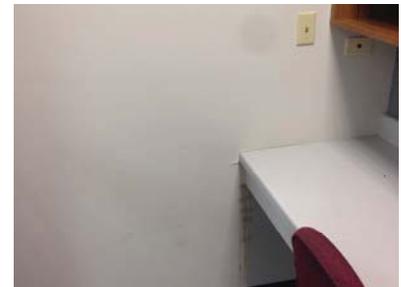
Figure 21. Damage @ Study Rooms

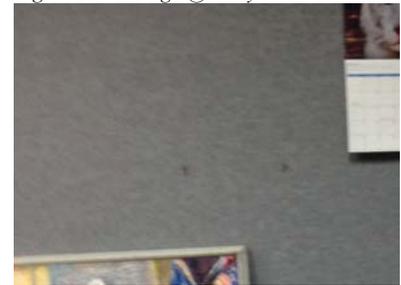
Figure 24. Staining @ Conf. Rm

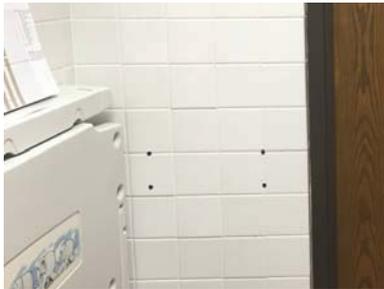
The condition of the ceramic wall tile inside the public restrooms throughout is in poor condition. The 4x4 tiles appear to be damaged, chipped, and cracked at select locations. Also visible are abandoned gypsum board anchors left behind after the removal or relocation of wall hung devices.

Figure 25. Abandoned anchors @ tile

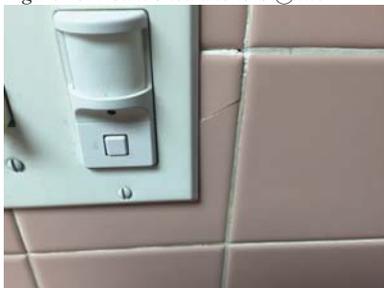
Figure 28. Cracking @ tile

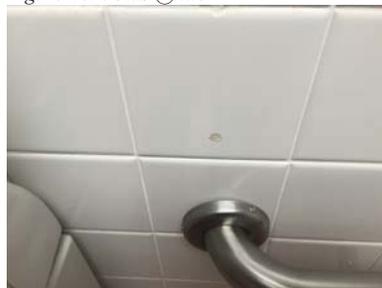
Figure 29. Chipping @ tile

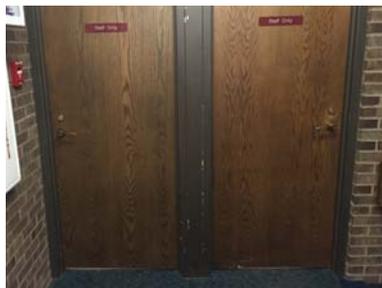
Figure 32. Wear on door frame

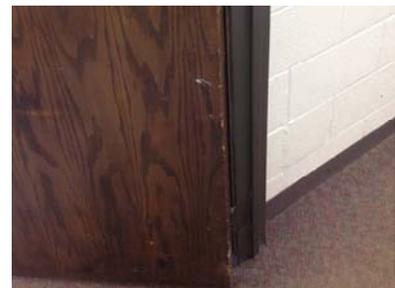
Figure 33. Wear on door panel

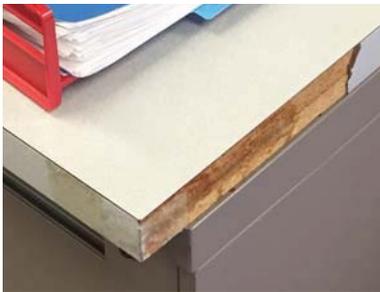
- A. The various types of base cabinetry and associated counters have all shown evidence of considerable wear and associated damage. The most common evident sign of deterioration is the delamination of the plastic laminate or veneer. The following additional concerns were observed with the base cabinetry and counters: chipping and splitting of the woodwork edges and associated finishes, and exposed sub-top for solid surface counters
- B. The wall cabinetry is better protected than the base cabinetry since they either are located within private offices or are above the plane of high traffic / impact compared to the base cabinetry where a large quantity is comprised the service desks actively use; therefore, the condition of the wall cabinets are considerably less degraded.

Figure 40. Delamination of the plastic laminate counters

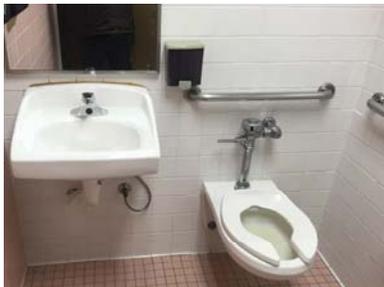
Figure 49. No 36" wide grab bar perpendicular to toilet centerline

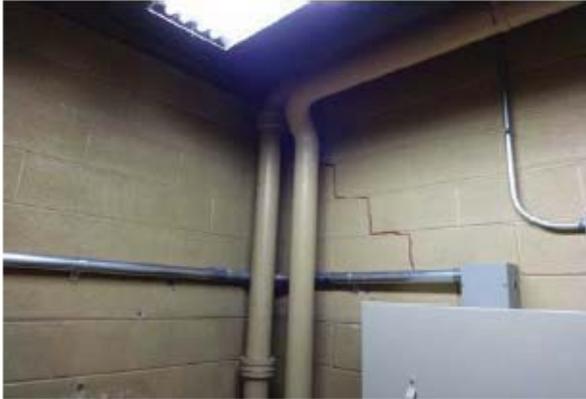
Drain pipes in the machine room. No leaks - generally, local code authorities require these be enclosed, but this is an existing condition.

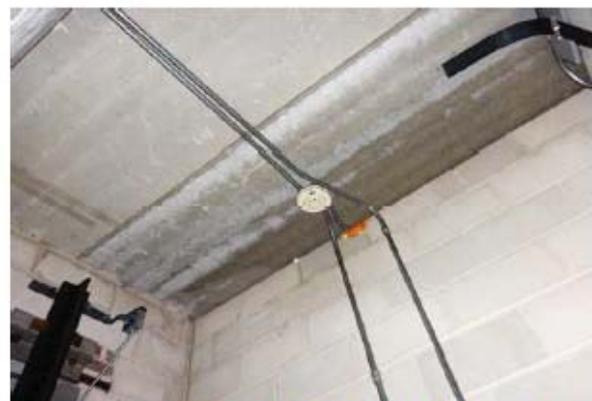
New smoke sensor in hoistway. There is a little moisture forming at the top of the hoistway along that back wall - could just be condensate.

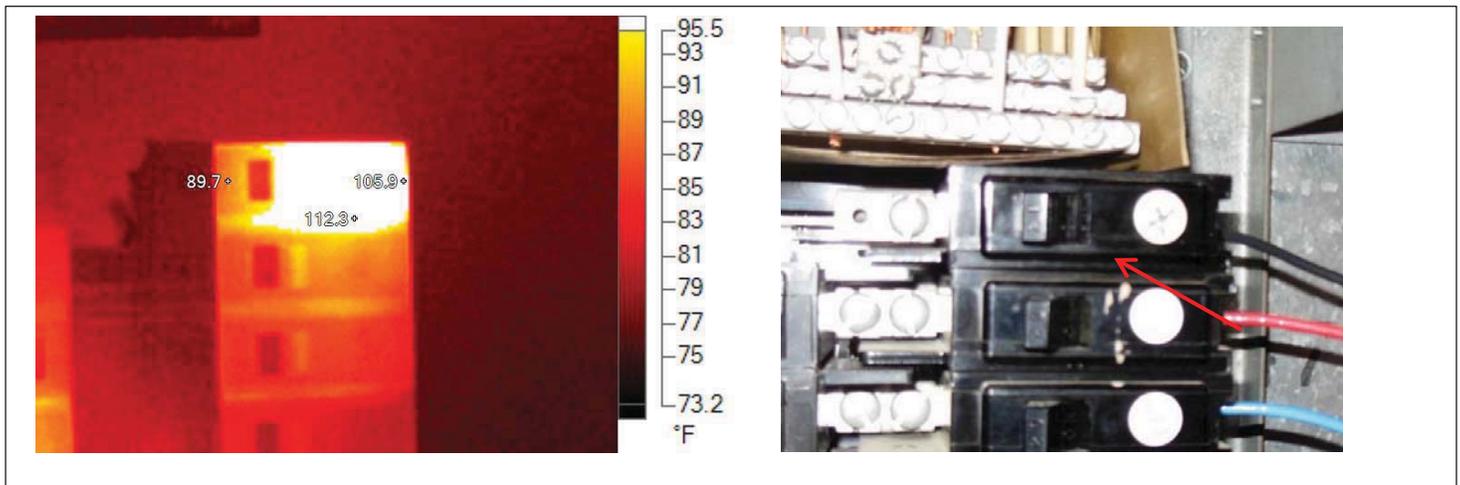
Problem Description: 20AF CIRCUIT BREAKER POSITION #2 MEASURED CURRENT:(18.0A)

ACTION REQUIRED		Probable Cause	Recommended Action
	Deficiency, Investigate	Loose Connection	Secure Power
	Schedule Repair at next outage	Oxidation of Conn	X Clean/Tighten Connection
	None: Problem Corrected during inspection	X Overloaded Circuit	Determine Cause of Imbalance
X	Repair and verify with infrared inspection	Unbalanced Circuit	Distribute Load evenly
	(P) Point Temperature	Failing (Bad) Fuse	Determine cause of overload
		Failing Breaker	X Reduce load below 80% FLA
		Code Violation	Replace Conductors
		Failing Contactor	Replace Fuses
(P1) Temp	(P2) Temp		Replace Bus
89°F	106°F		Replace Breaker
Hot Temp	112°F

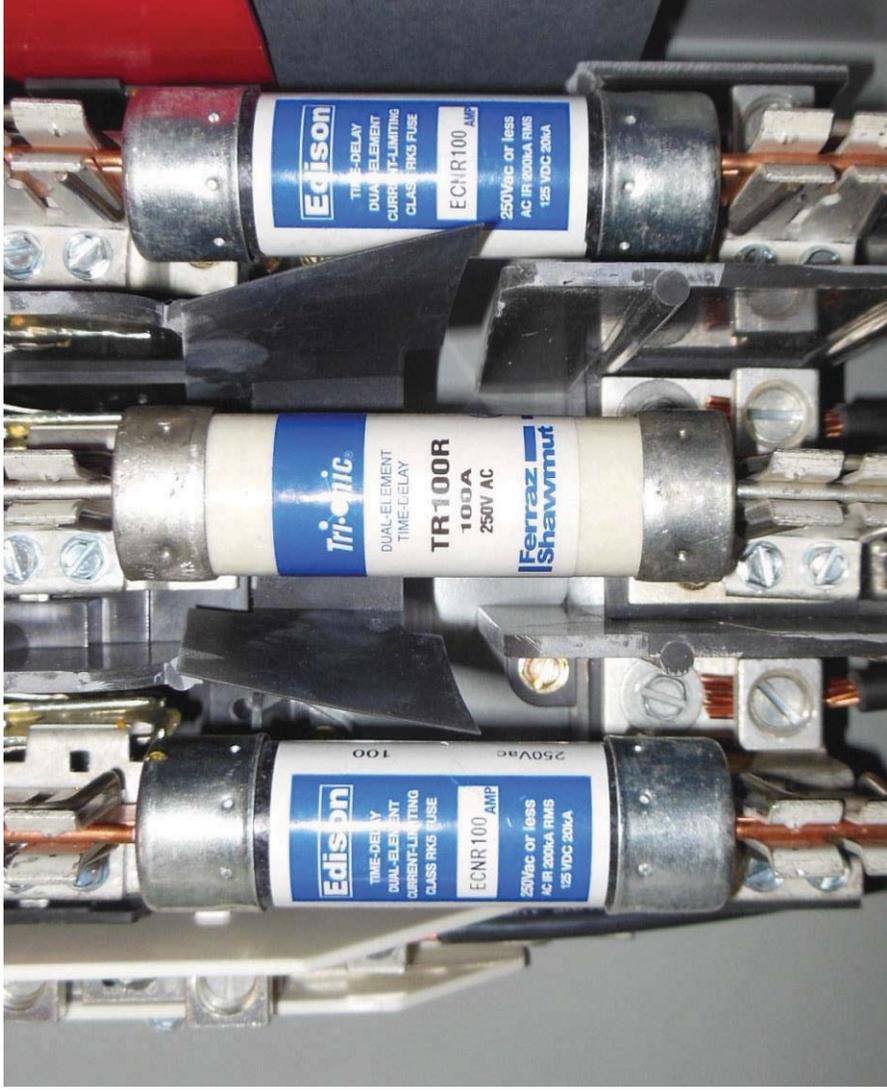
ELEVATOR MAIN CRK DISCONNECT

2 DIFFERENT FUSE TYPES ECNR AND TR. WE RECOMMEND REPLACING WITH IDENTICAL FUSES.

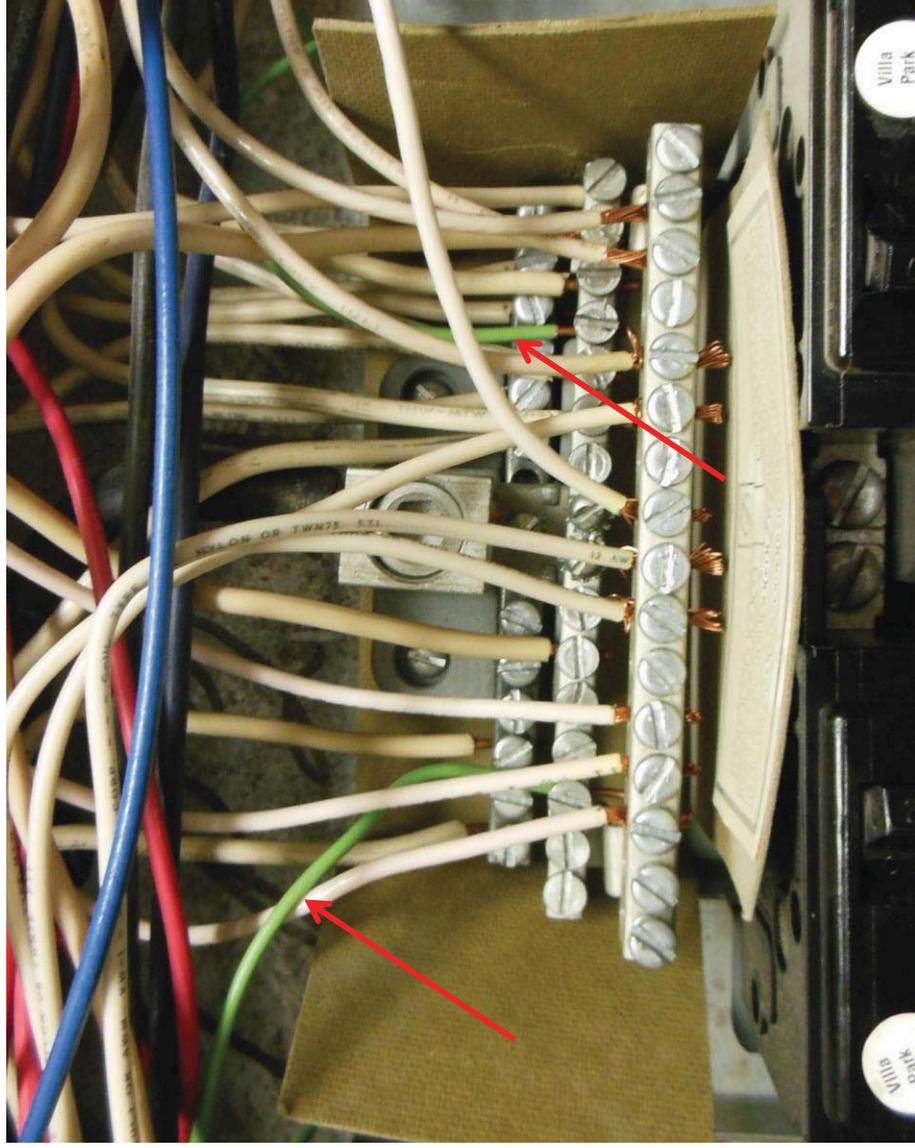
PANEL LP-2-A

GROUND WIRES FOUND ON NEUTRAL TERMINAL.
REMOVE AND CONNECT TO GROUND BUS.

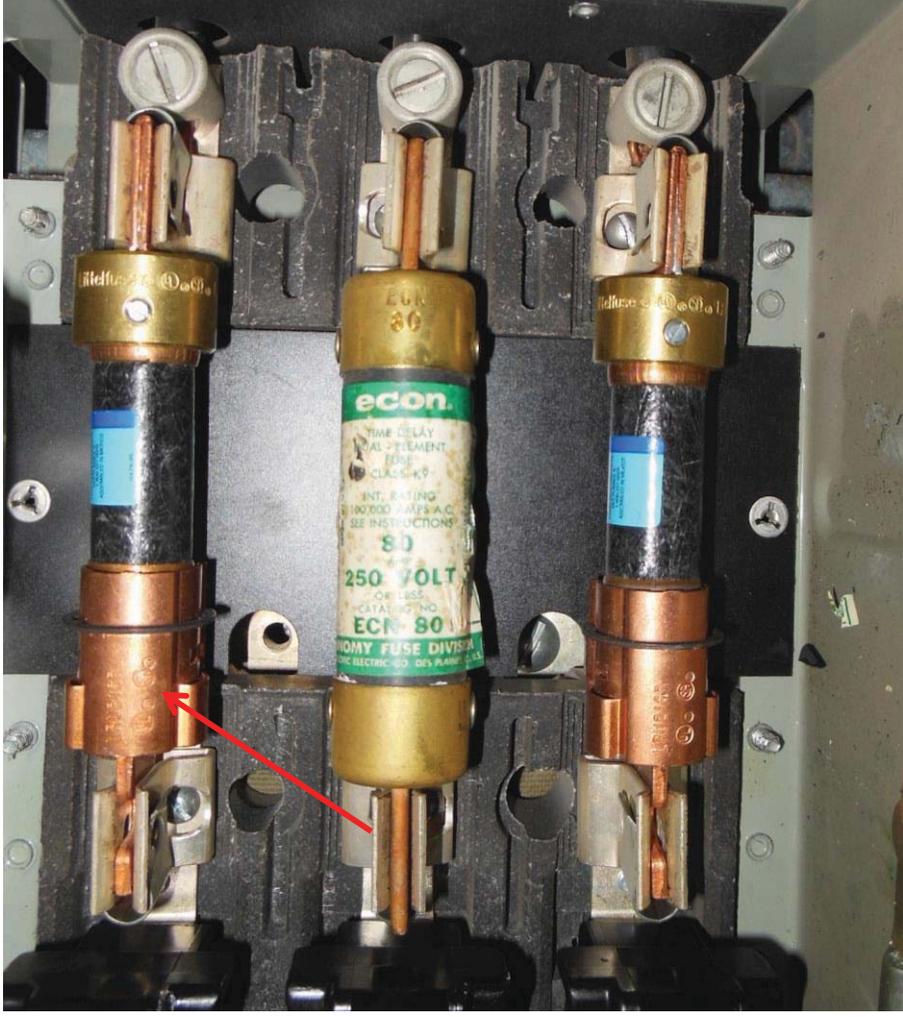
MCC COND UNIT #6 FUSED DISCONNECT

2 DIFFERENT FUSE TYPES FUSE EXTENDERS BEING USED.
RECOMMEND REPLACING WITH SAME TYPE AND SIZE FUSES
WITHOUT THE FUSE EXTENDERS.

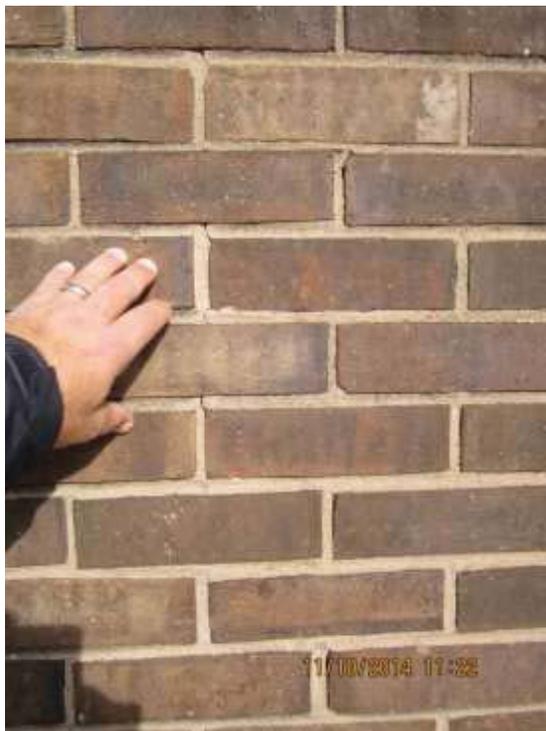
Brick Mortar Joints – The mortar joints are generally in fair condition with deterioration and erosion typically occurring at the top portions of the projecting bay/piers, along the corners of the bay/piers, adjacent to embedded downspout drains, and at localized areas in the wall. There were also isolated locations of cracked mortar joints throughout the walls. Refer to Photos 5 – 8.

Photo No. 6. Typical mortar cracks and deterioration.

Recommendation: We recommend repointing 100% of the top portion of the piers and down the corners several feet, as well as localized repointing of other isolated areas as necessary.

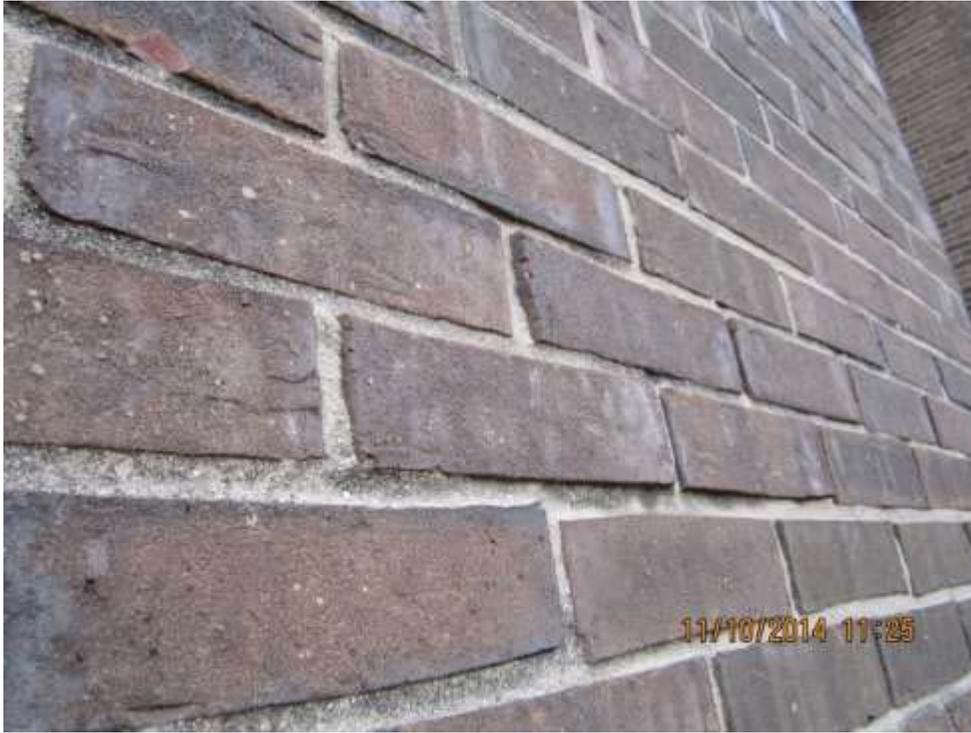
Photo No. 7. Mortar erosion.

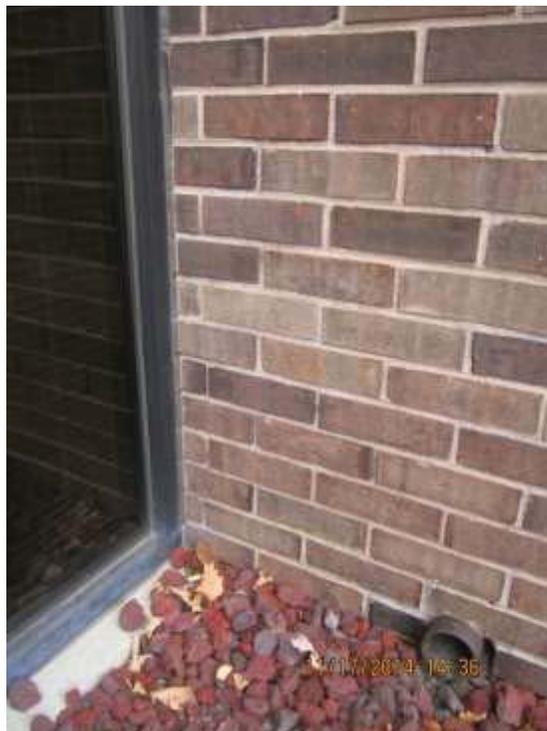
Photo No. 8. Mortar deterioration adjacent to roof gutter and directly outside of interior efflorescence.

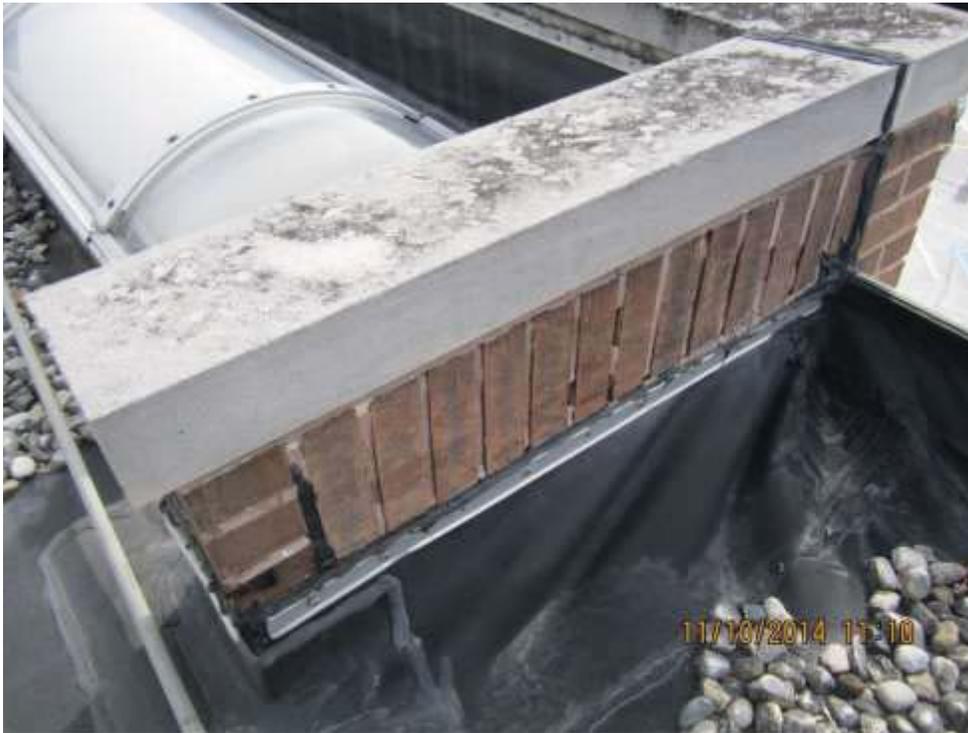
Brick Parapet Walls – There are short parapet walls atop the bay/piers that are capped with limestone coping stones. The joints between coping stones are sealed, but the sealant is deteriorated and open, allowing water into the masonry below. The top courses of masonry at the parapet walls are in poor conditions with numerous cracked and open mortar joints, allowing water to freely enter the walls. There also does not appear to be an effective through-wall flashing below the coping stones. Refer to Photos 9 & 10.

Photo No. 9. Brick deterioration directly below pier copings at return walls.

Recommendation: Rebuild 100% of the parapet walls at the bay/piers. Install through-wall flashing below the coping stones and seal the coping stone joints

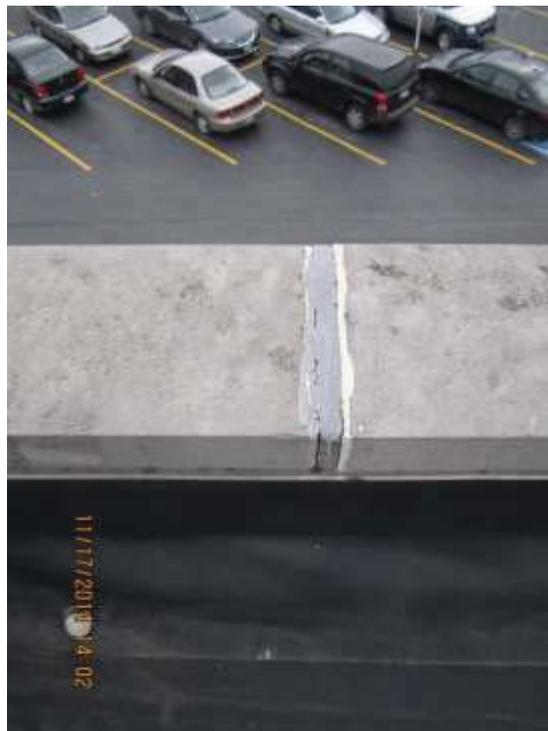
Photo No. 10. Deteriorated coping sealant joint.

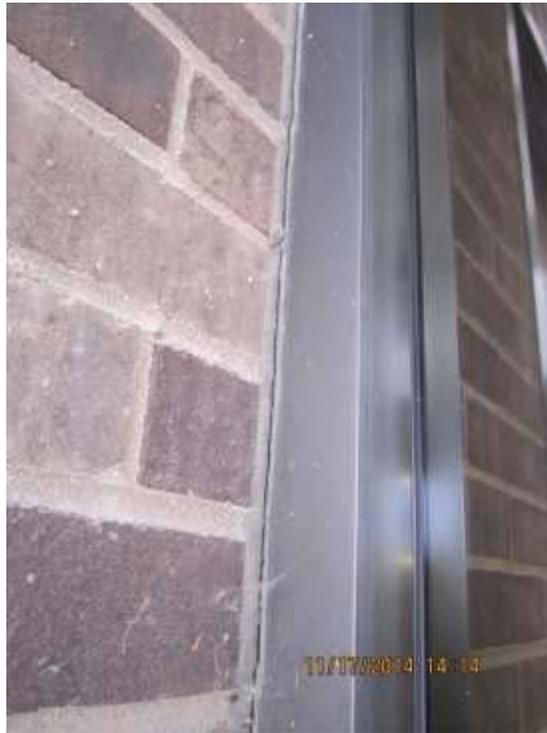
Window Perimeter Sealant – At the majority of the windows, the perimeter sealant was found in fair to poor condition, with numerous areas of failed and open joints. Replacement of perimeter sealant at isolated locations has occurred; however, this sealant was installed leaving upper portions of the joints open. This allows water to freely enter the top portions of the joint, thereby trapping the water behind the newer sealant below. Refer to Photos 11 & 12.

Photo No. 11. Failed window perimeter sealant.

Recommendation: Replace 100% of the window perimeter sealant.

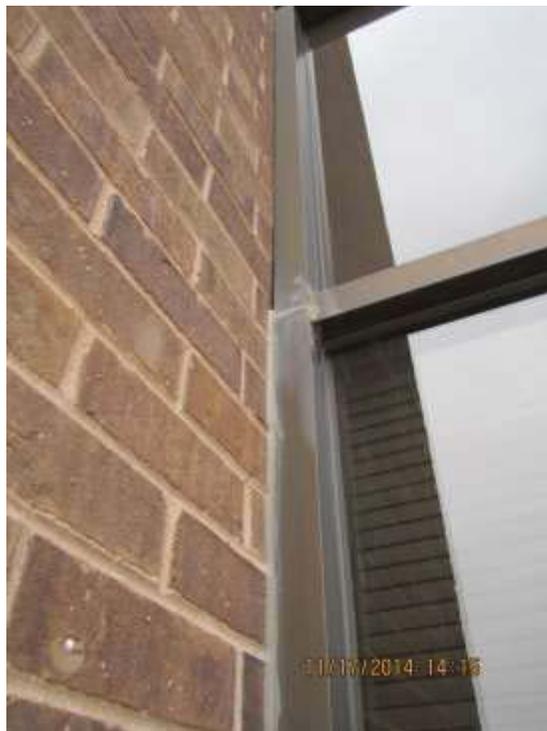
Photo No. 12. Window perimeter sealant at lower portion, but no sealant above allowing water to enter behind sealant.

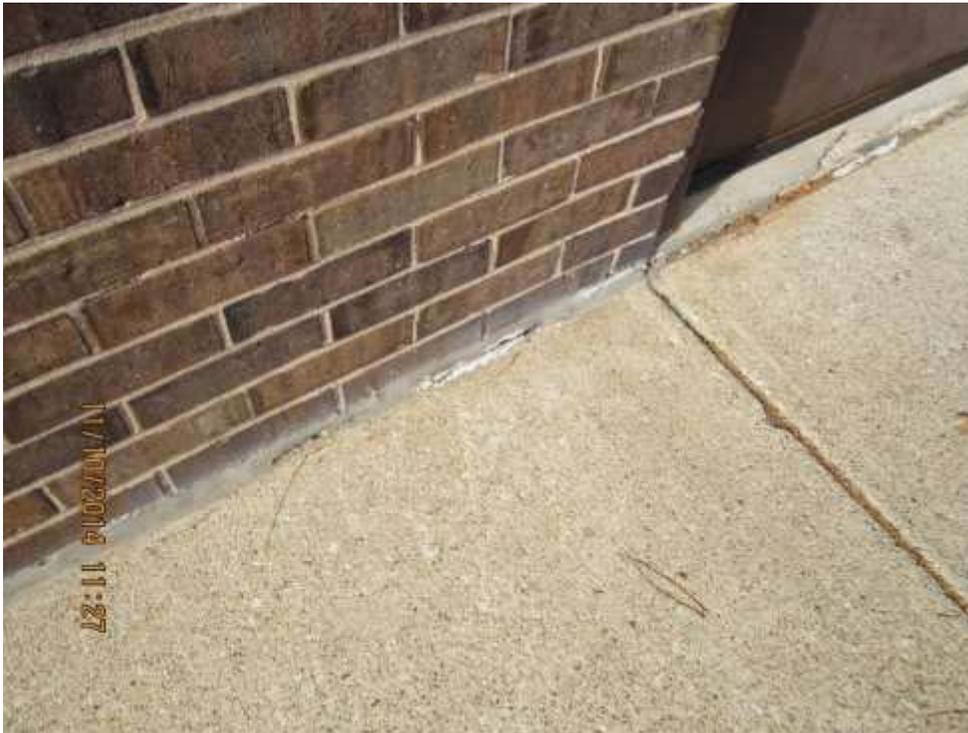
Brick/Concrete Sidewalk Joint Sealant – The joint between the concrete sidewalk and brick masonry is typically deteriorated and open. See Photo 13.

Photo No. 13. Failed sealant joint at sidewalk-to-building joint.

Recommendation: Replace 100% of the concrete sidewalk to brick sealant.

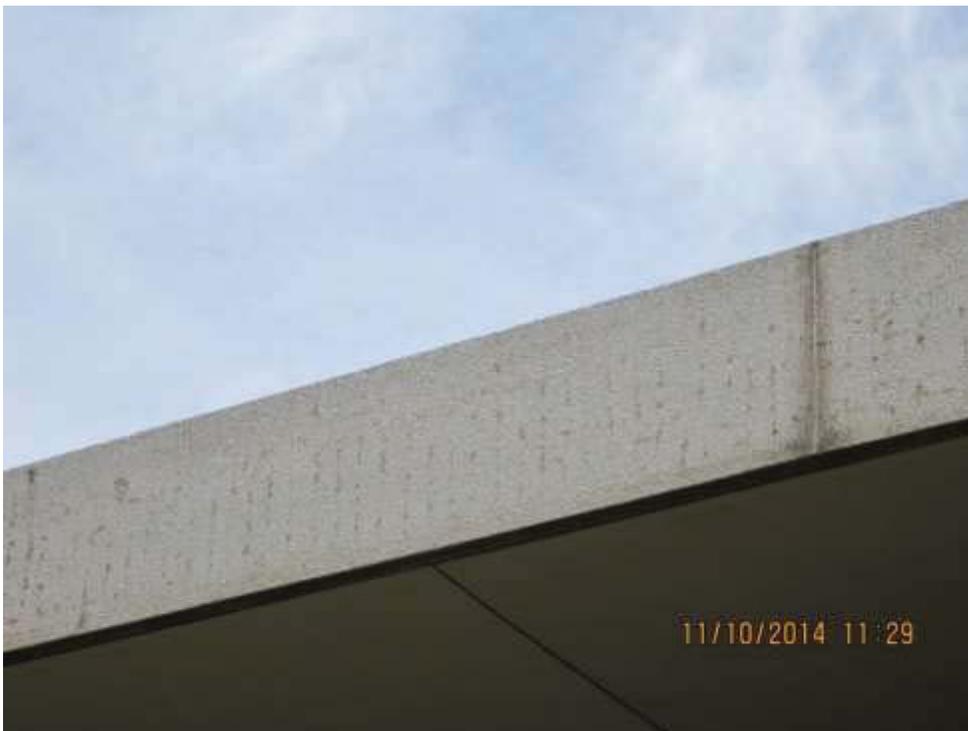
Staining – There is extensive brown staining of the fascia panels, which varies from random spots on many of the panels to regular vertical striping on the panels at the west façade. See Photo 14. The cause of the staining is unknown, but may be related to corrosion of internal reinforcing steel.

Photo No. 14. Staining pattern on concrete fascia panels at west façade.

Long Term: Replace the precast concrete fascia panels with new panels. Depending on the desired aesthetic look, the panel materials and finishes that may be considered are numerous, including metal panel systems, glass-fiber reinforced concrete, and many others.

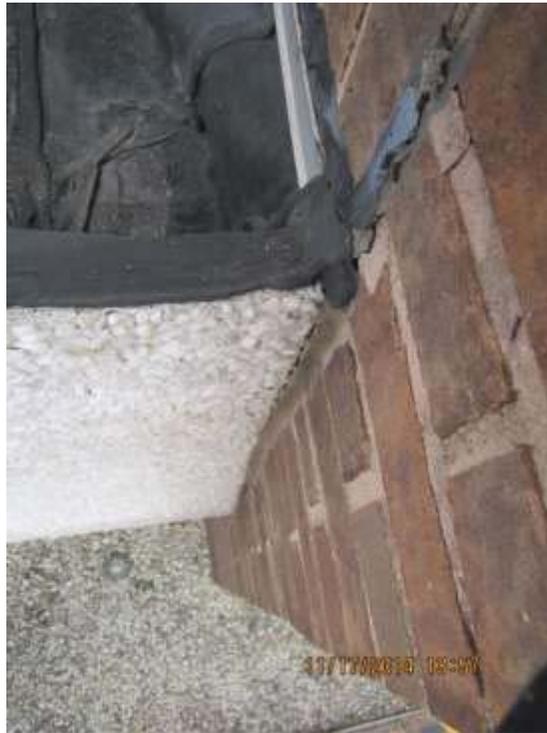
Sealant Joints at Precast Concrete Fascia Panels – The majority of these joints are deteriorated and many have failed. See Photo 15

Photo No. 15. Example of bowed concrete fascia panel and failed sealant joint.

Recommendation: Replace 100% of the sealant joints at the fascia panels; however, see further information regarding the fascia panel repair recommendations below.

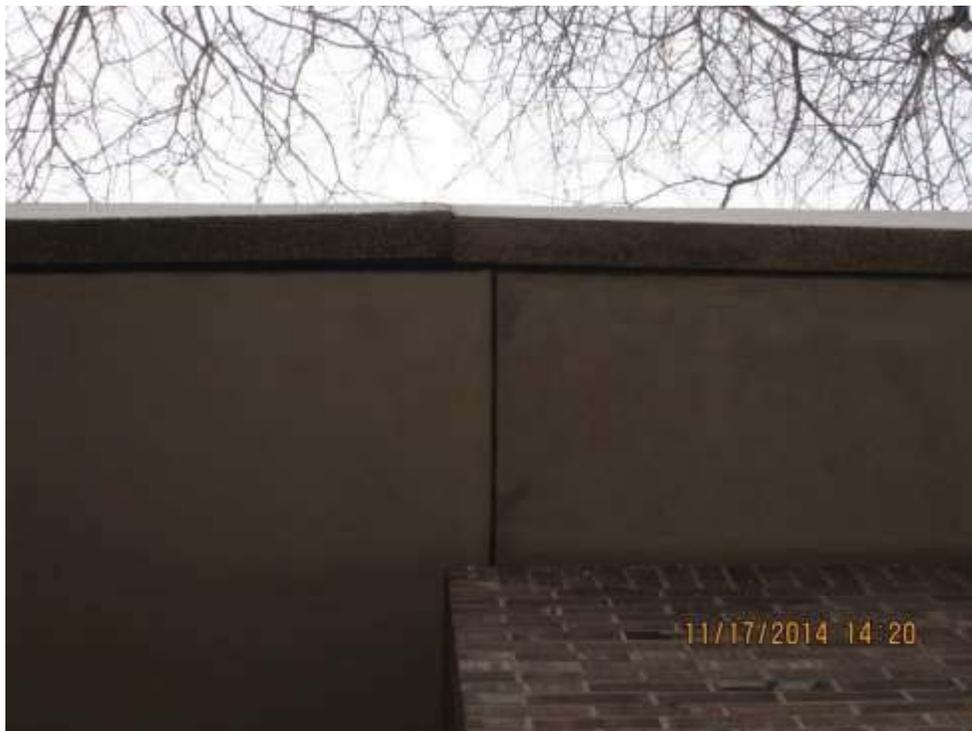
Photo No. 16. Visible displacement of concrete fascia panels at joint.

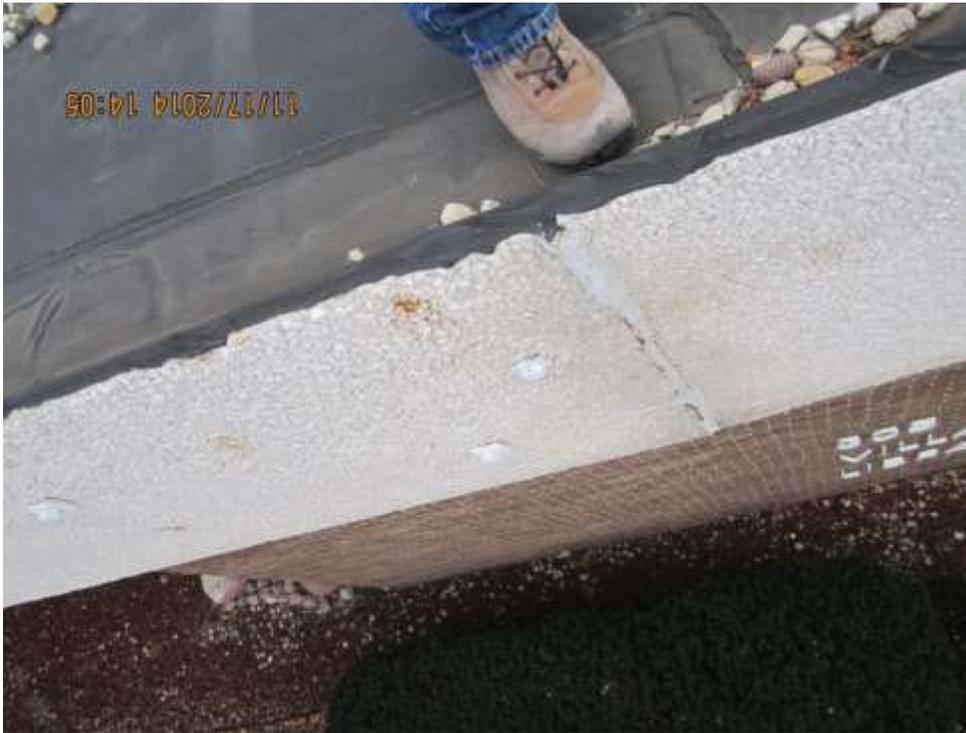
Previous Panel Repairs – Reportedly, in 2009 a portion of a concrete fascia panels at the west façade was severely dislocated and required emergency stabilization repairs to reattach the panel. No report was available for review to identify the extent or methodology of repairs. K&H contacted the repair contractor, Bulley & Andrews (B&A), for additional information, but at this time no repair files have been located or received. Our inspection revealed that through-face anchors are visible at the end of one panel in the general area where the dislocated panel was reported. Refer to Photo 17.

Photo No. 17. Concrete fascia panels at east façade at location of previous stabilization repairs. Note the panel displacement and failed sealant joint.

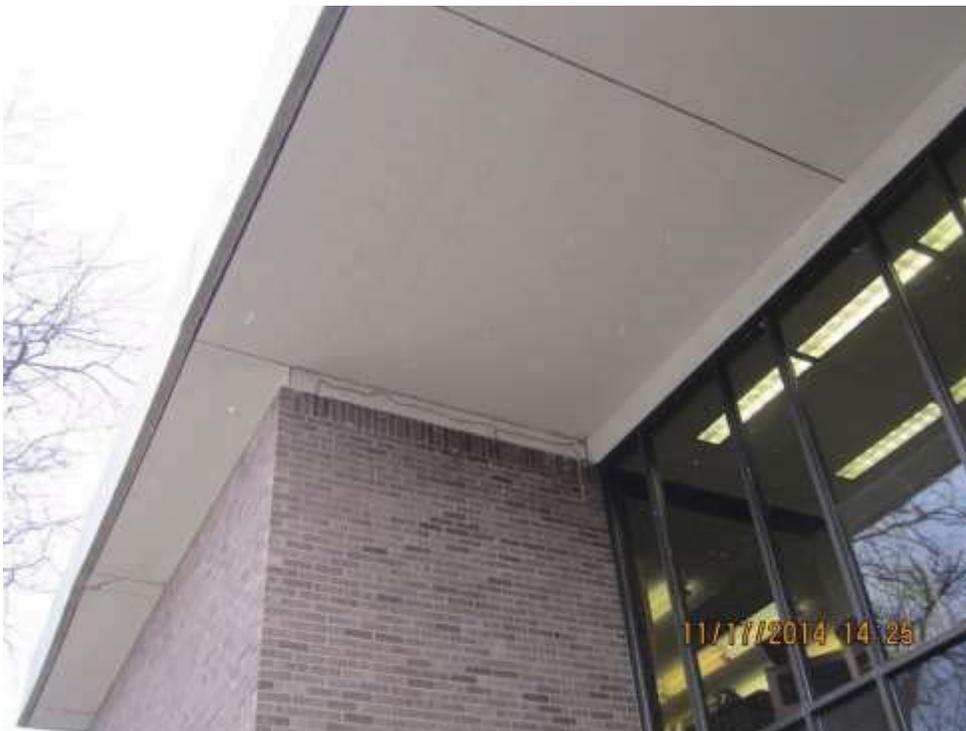
Photo No. 18. Example of localized cracking and sealant repair of stucco/plaster soffit.

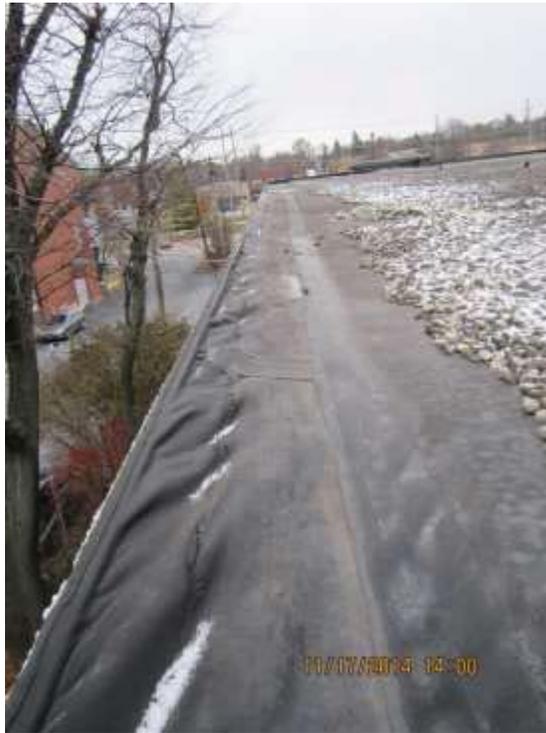
Photo No. 21. Severe stretching of roof at perimeter condition. Note that the edge of the roof is sealed to the thin top edge of the concrete fascia panels.

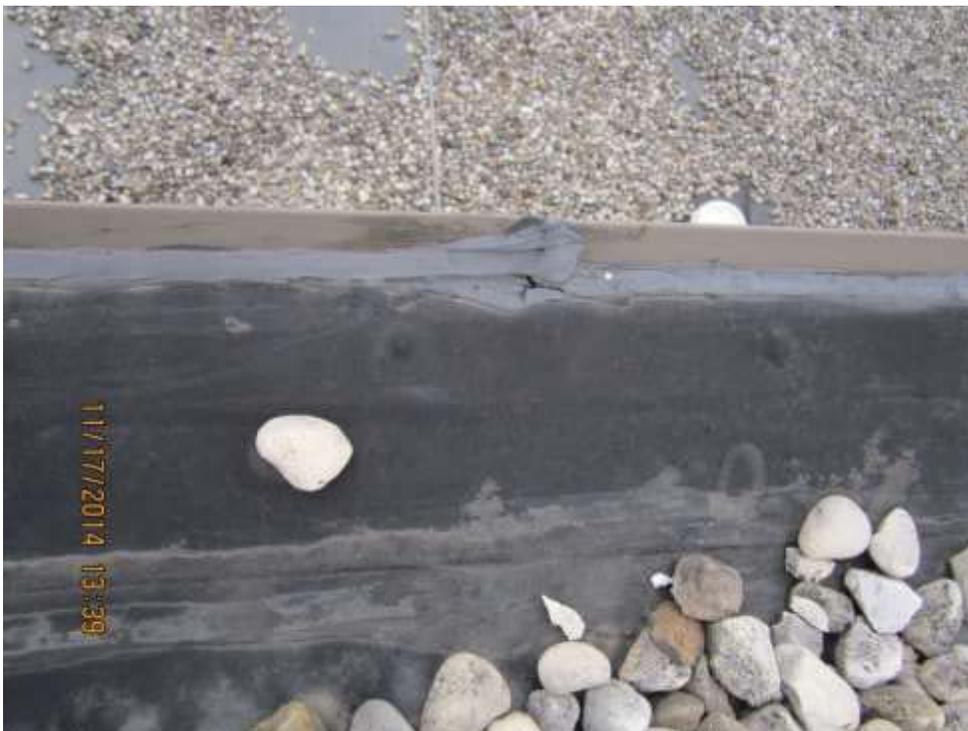
Photo No. 22. Example of failed seal at the perimeter of the penthouse roof.

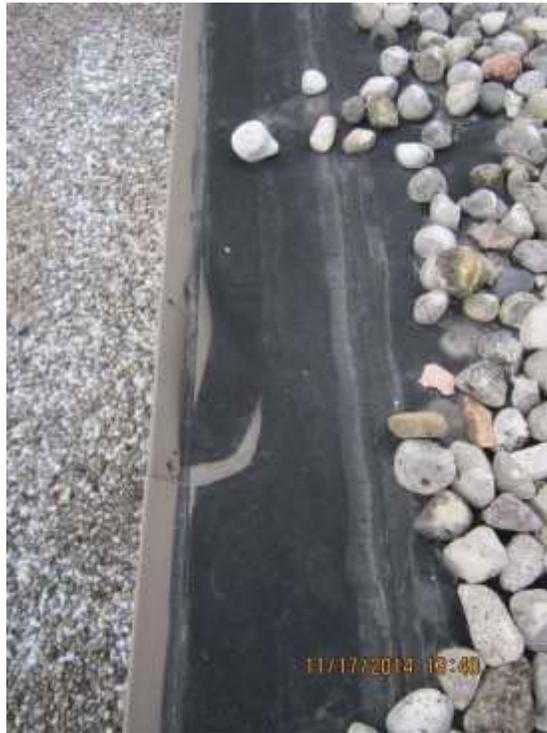
Photo No. 23. Torn and open roof flashing at perimeter of penthouse roof.

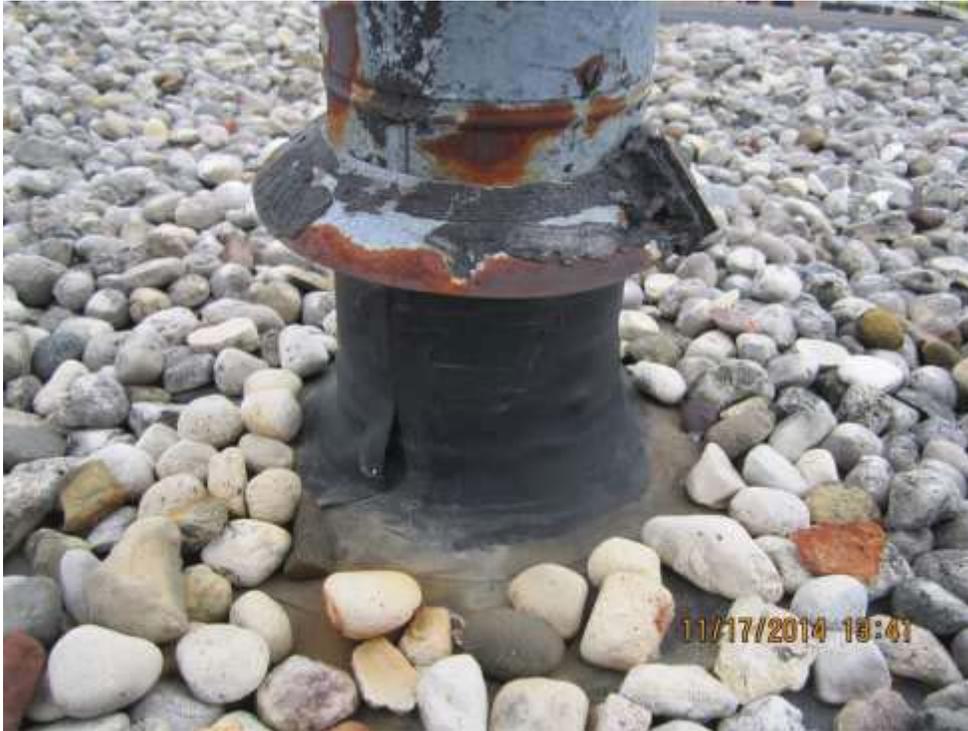
Photo No. 25. Open seam at roof flashing. Note the corroded vent metal.

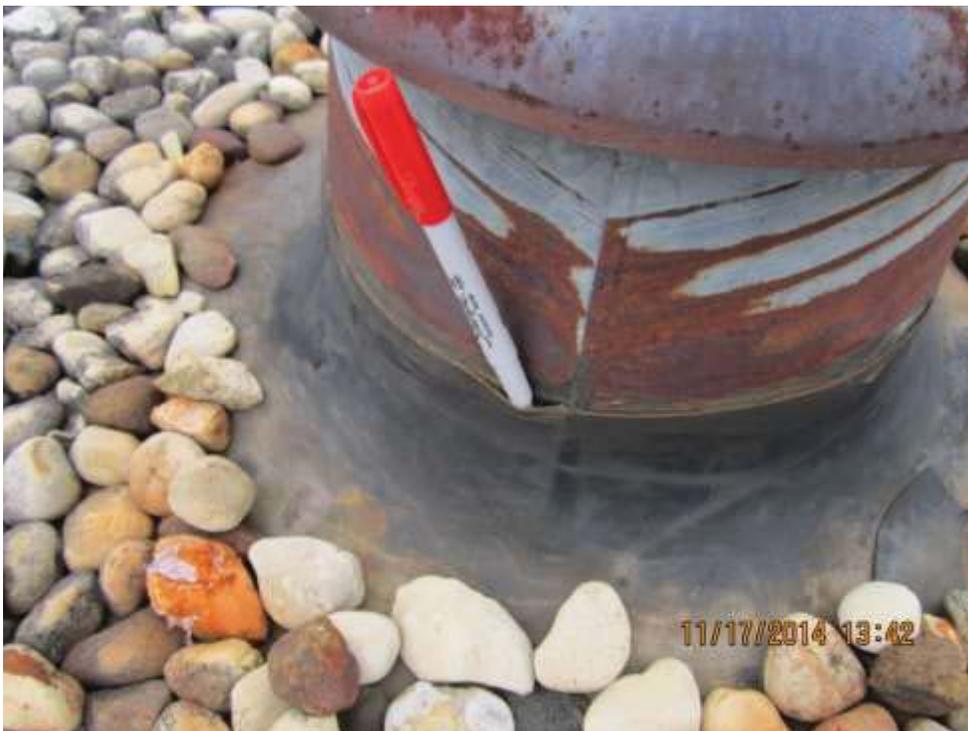
Photo No. 26. Roofing flashing at vent penetration with inadequate height. No mechanical termination or seal exists at the top edge of the roofing.

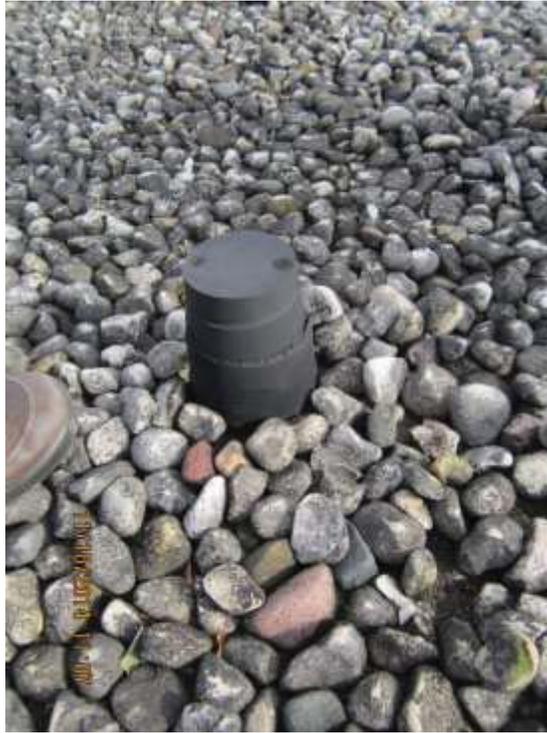
Photo No. 27. Failed termination seal and no mechanical termination at a roof system vent.

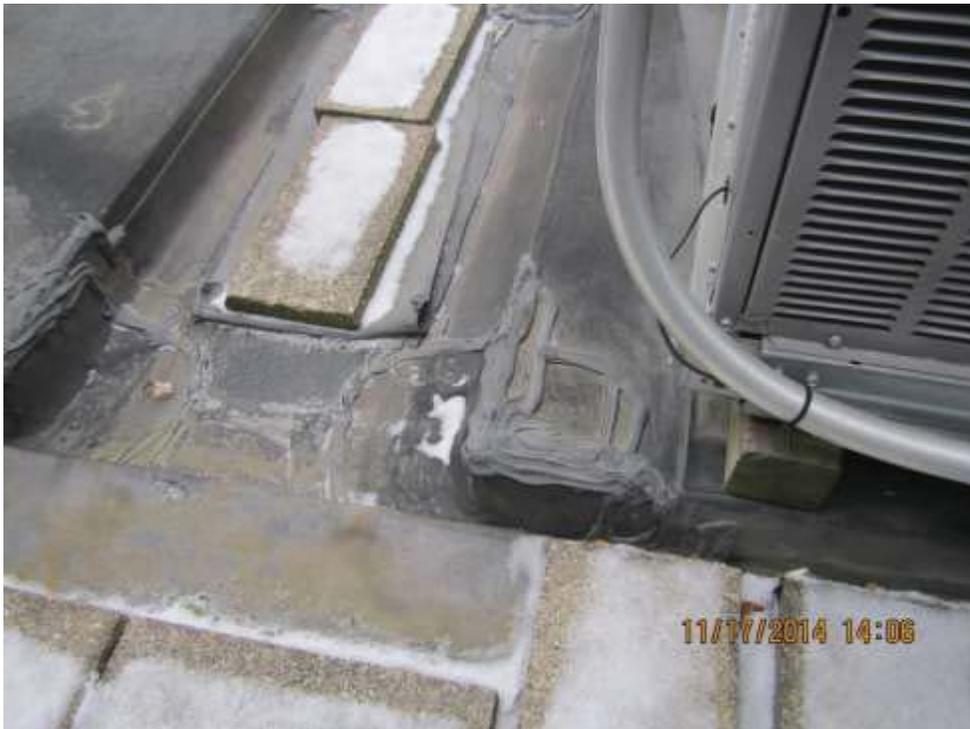
Photo No. 28. Example of numerous sealant repairs at roof seams.

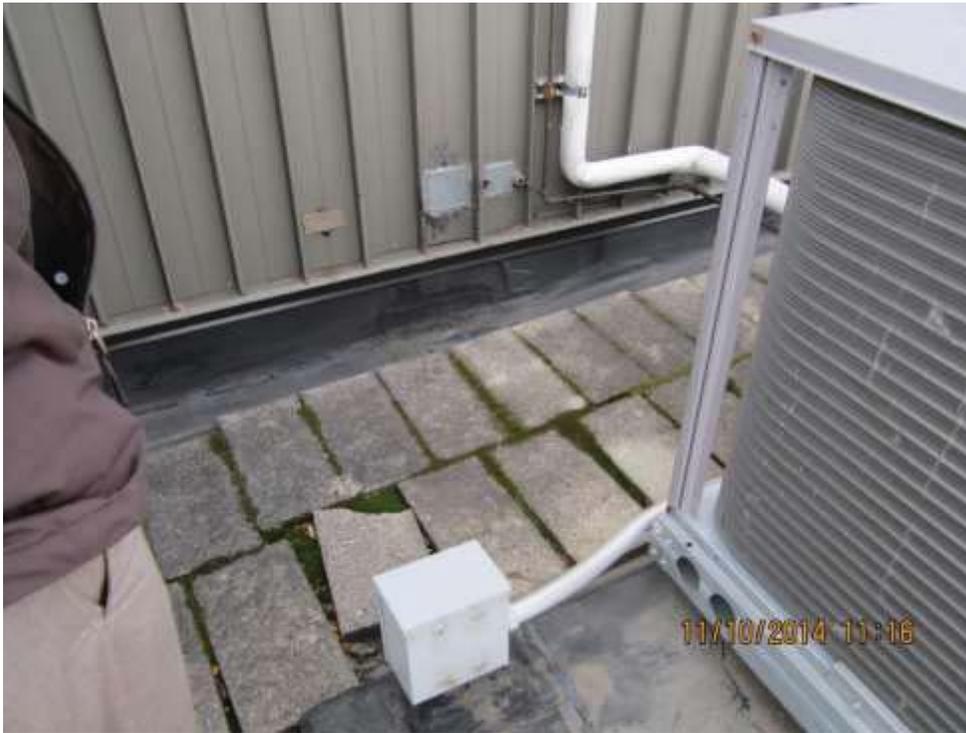
Photo No. 29. Collection of dirt and debris between pavers, and resulting organic growth atop roofing membrane.
