FACILITY ANALYSIS

VILLA PARK PUBLIC LIBRARY

Final Report

March 4, 2015

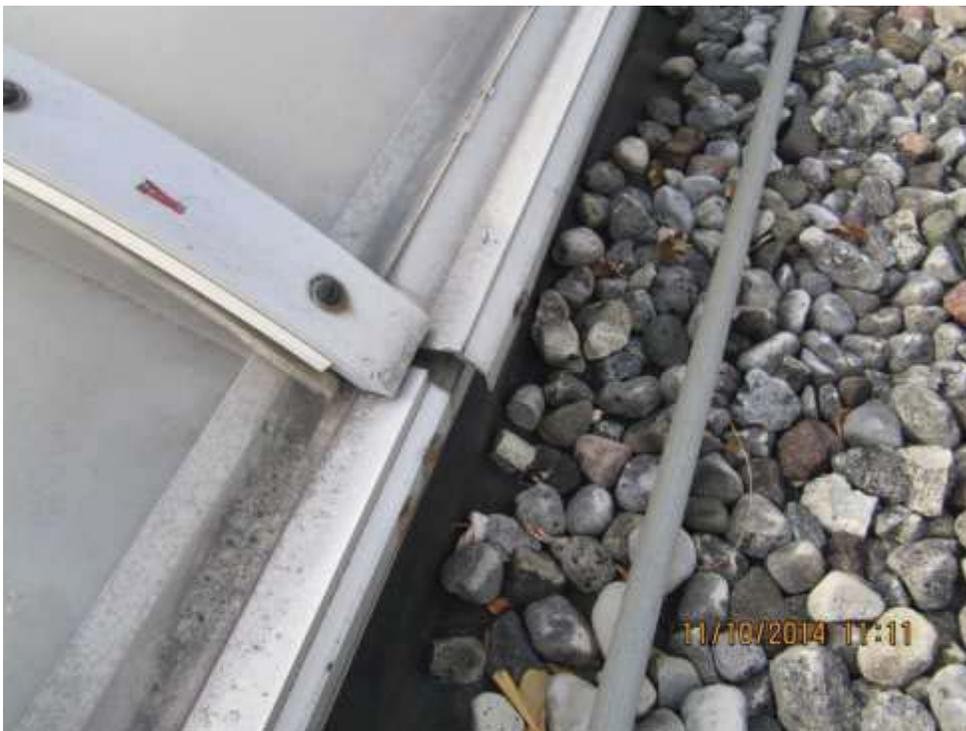
Photo No. 30. Skylight along south side of roof with dislocated framing members and deteriorated glazing seals.

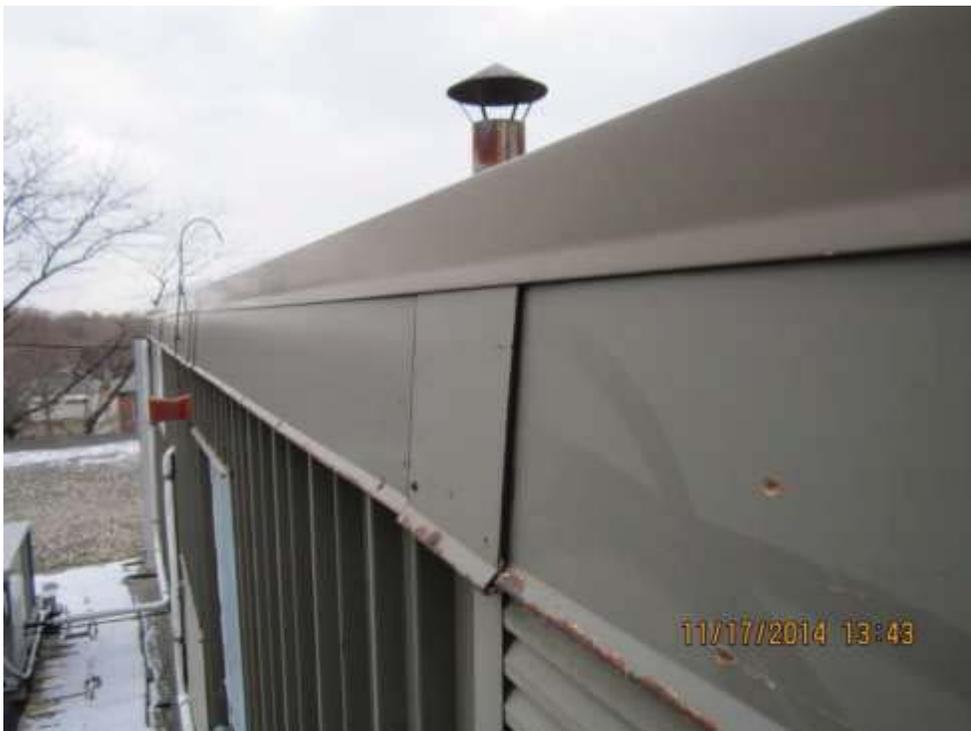
Photo No. 32. Loss of protective paint coating and corrosion of metal at penthouse.

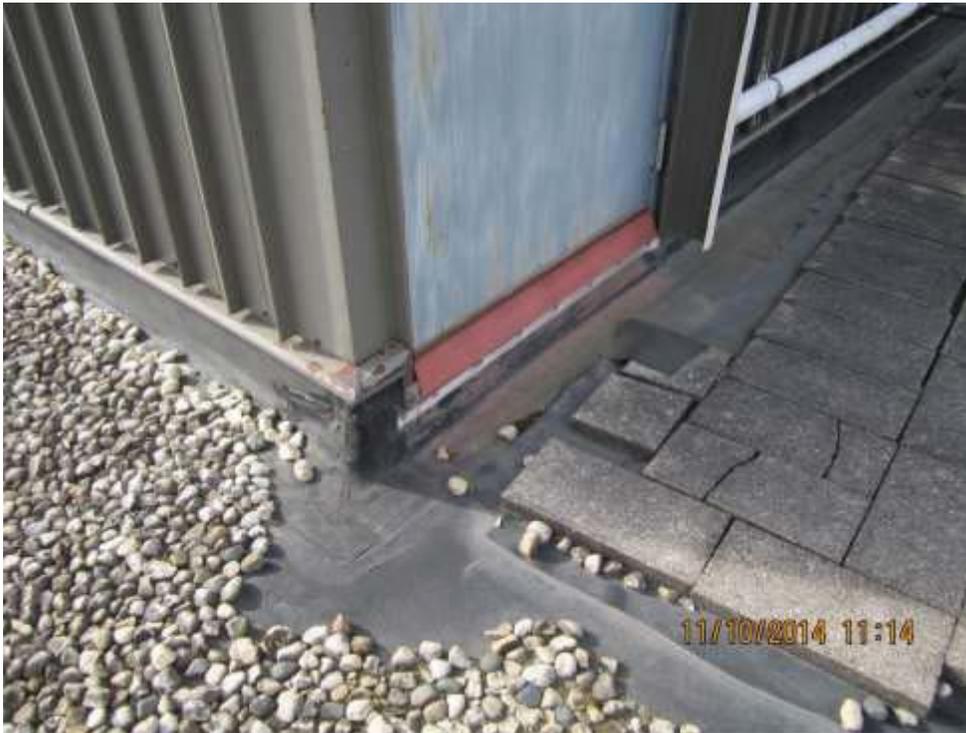
Photo No. 33. Poor roof flashing (with inadequate height) below penthouse door threshold.

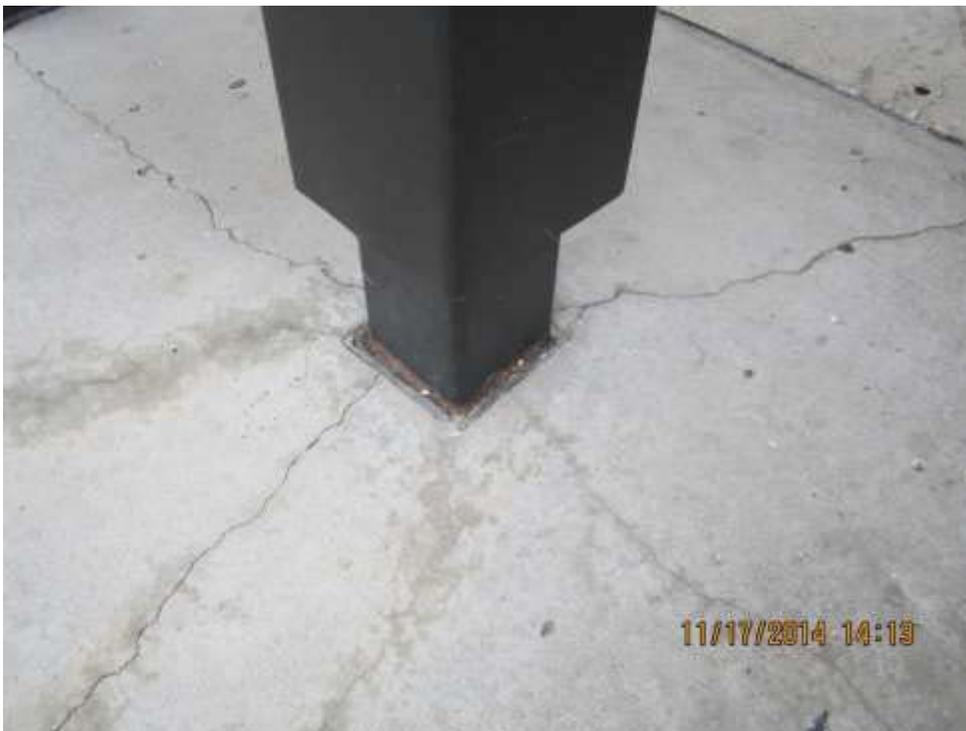
Photo No. 34. Corrosion of embedded steel post at entry canopy.
