FACILITY ANALYSIS

VILLA PARK PUBLIC LIBRARY

Final Report

March 4, 2015

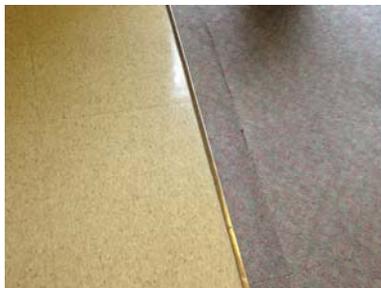
Figure 5. Seaming and wearing issues @ transition strip @ stacks area

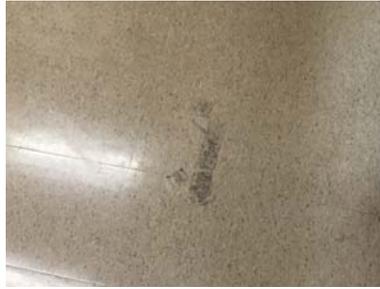
Figure 8. Marking/ residue visible @ 2nd floor stacks area

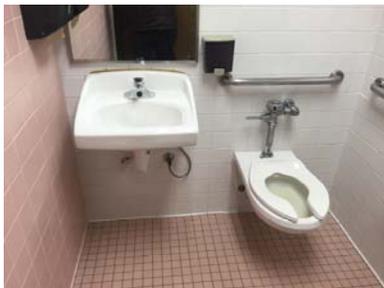
The condition of the ceramic floor tile inside the public restrooms at the second floor is in poor condition. The mesh-backed mosaic 2x2 tiles appear to be delaminating from the substrate within the Girls's Toilet Room and is likely caused by water leaking from the adjacent plumbing fixtures. Additional concerns include darkened grout, wearing, and cracking at select locations due to traffic, use, and abuse.

Figure 13. Tiling at Men's Toilet Room

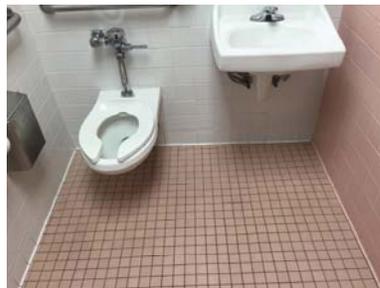
Figure 14. Tiling at Women's Toilet Room

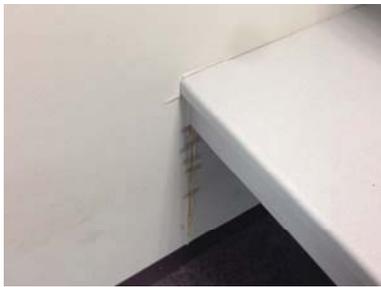
Figure 20. Damage @ Study Rooms

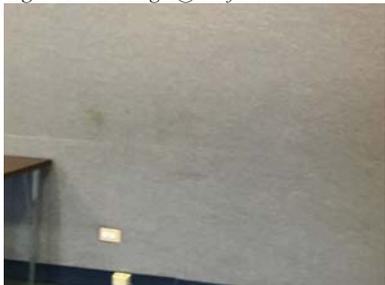
Figure 22. Staining @ Story Time Rm

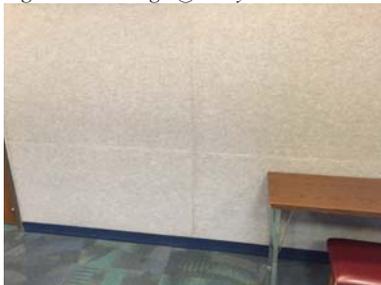
Figure 23. Discoloration @ Story Time Rm

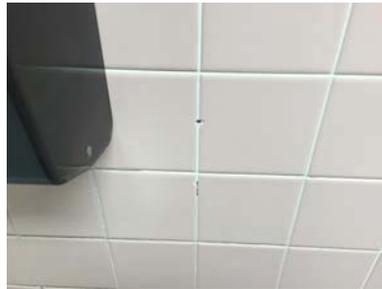
Figure 26. Voids @ tile

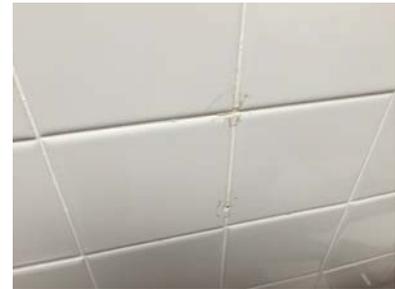
Figure 27. Chipping @ tile

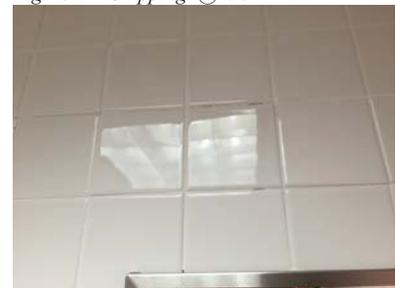
Figure 30. Grout voids @ tile

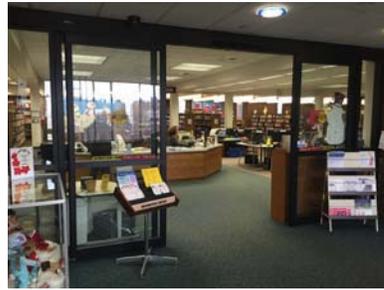
- C. Custom-built Wood Frames:
The wood door frames are in fair condition and are showing the expected signs of wear and tear for a product their age.
- D. Aluminum Framed Doors and Lites:
The aluminum framed doors and lites are in good condition. The automatic sliding doors are no longer operational and remain in the open position permanently.

Figure 35. Non-functional Automatic Sliding doors

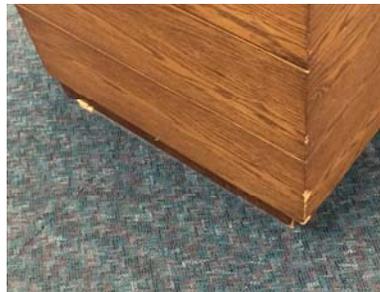
Figure 41. Chipping of the wood base cabinetry (service desk)

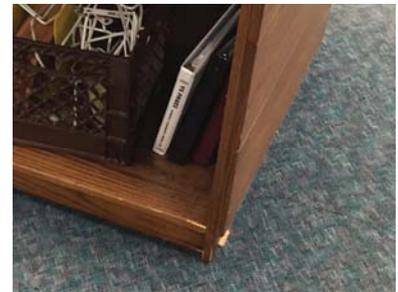
42. Chipping of the wood base cabinetry (service desk)

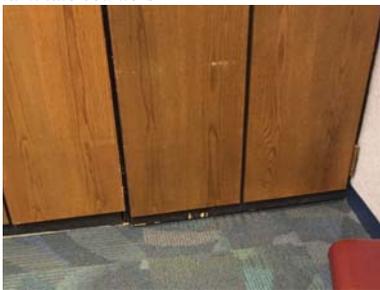
43. Chipping of the wood base cabinetry (service desk)

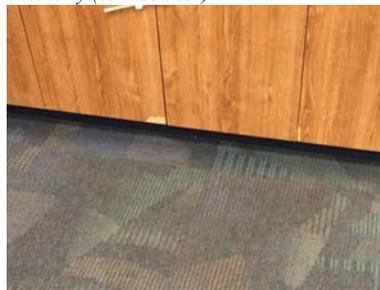
44. Delamination of the wood veneer on the base cabinetry (Story Time Room)

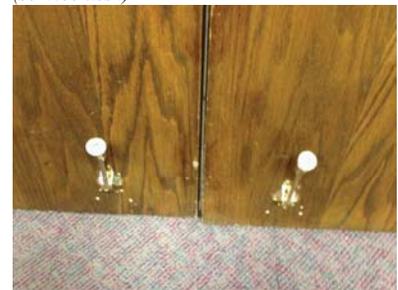
45. Chipping of the wood door panels

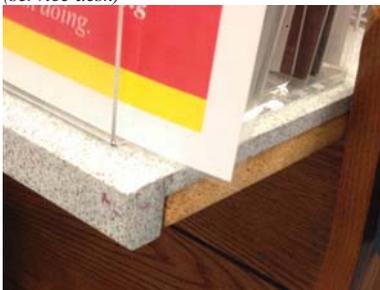
46. Counter sub-top exposed to view at side overhang

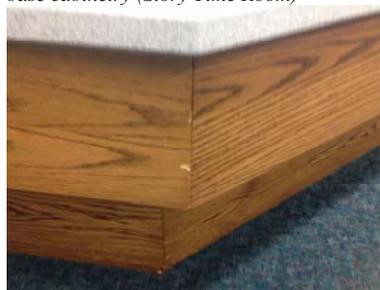
47. Chipping of the wood base cabinetry (service desk)

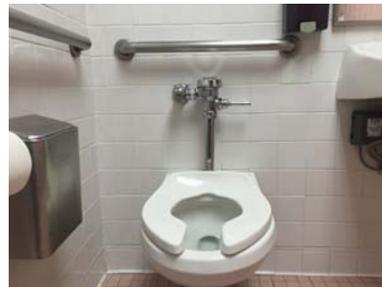
Figure 49. No vertical grab bar parallel to toilet centerline

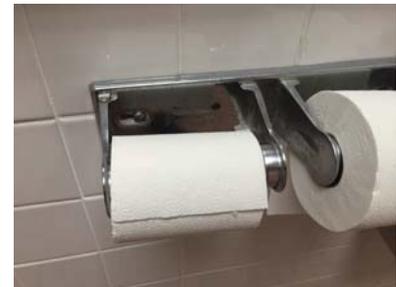
50. Aged bathroom accessories

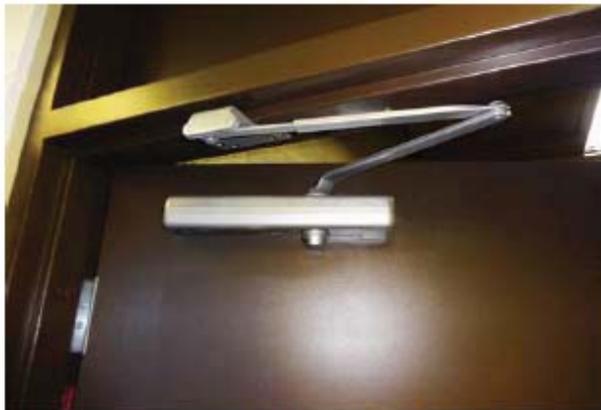
The machine room door is self-closing and self-locking, but needs a sign indicating that it is the elevator equipment room.

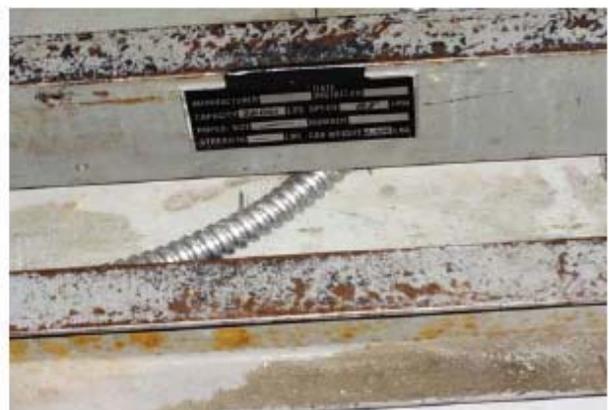
This is the data tag installed on the car top. It lists the car speed at 85 FPM. I called Craig at Colley and he is going to change the crosshead data tag to match the controller data tag, which is what the elevator is engineered for.

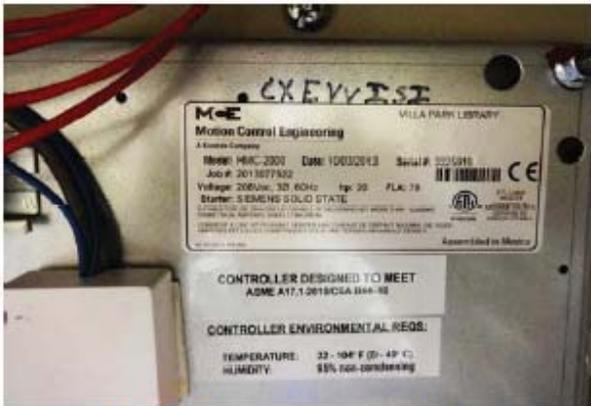
Controller installation information tag for future reference sake.

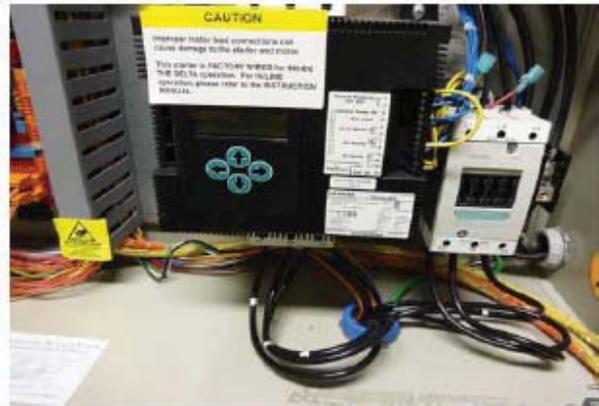
Specifications called for an electronic soft start system. This help reduce energy usage.

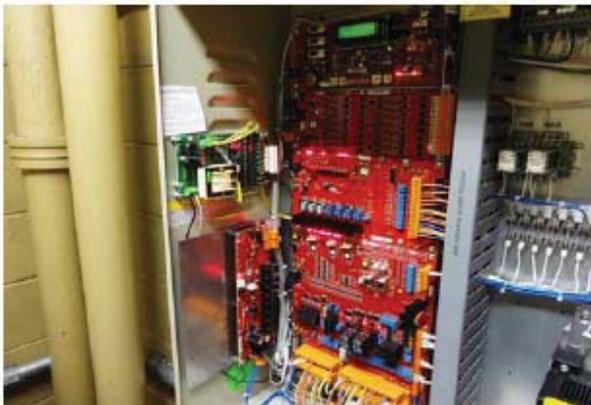
The new controller is a generic type, manufactured by MCE. Should last 30 years.

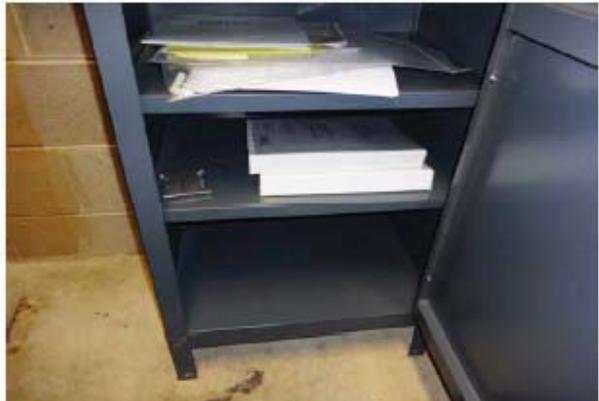
Parts cabinet contained all the necessary wiring diagrams and maintenance manuals. Spare parts would be nice. Perhaps a few interlock parts and some fixture parts and a couple of rollers for the cab door and hoistway door.

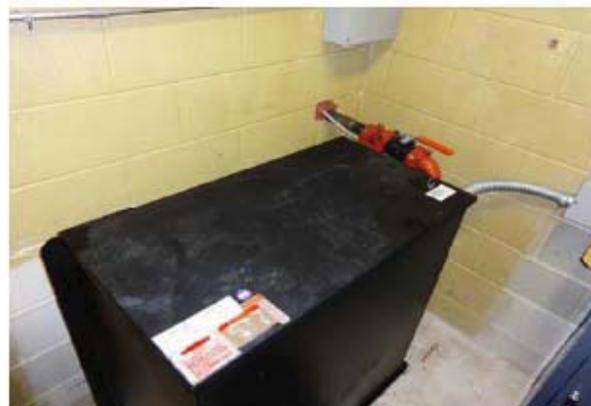
The specifications said the pump unit could be reused. Colley replaced the pump unit with a new unit.

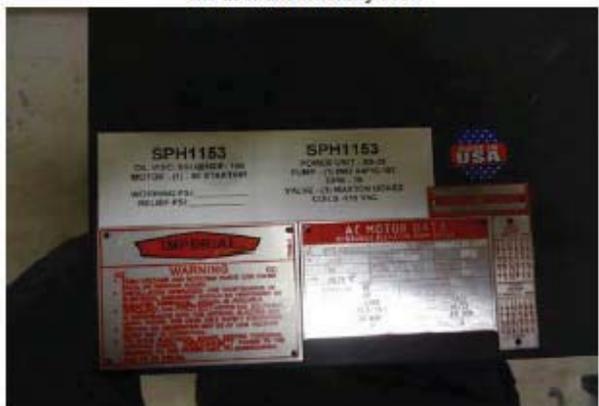
Pump data.

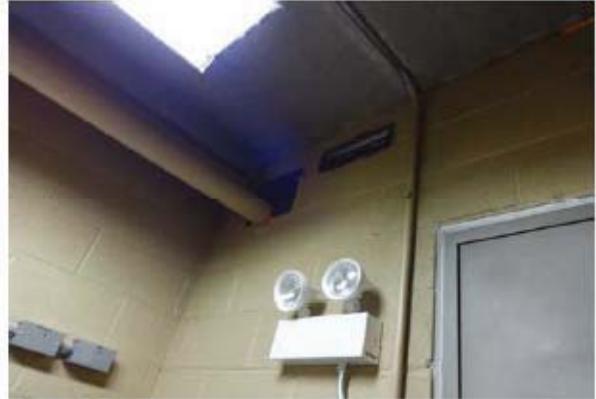
New lighting, including emergency lighting as well as ventilation duct near the top. Again, roof drain pipe is in the machine room.

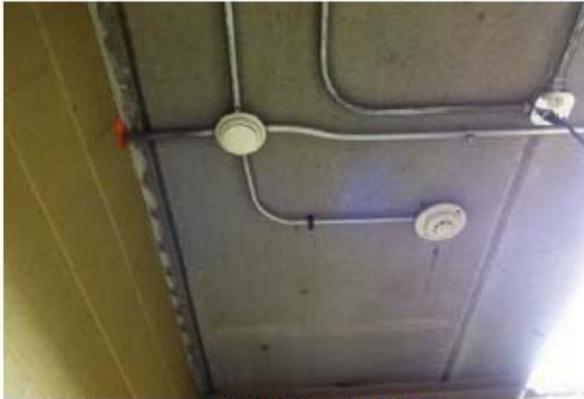
Machine room was updated with smoke and heat sensors.

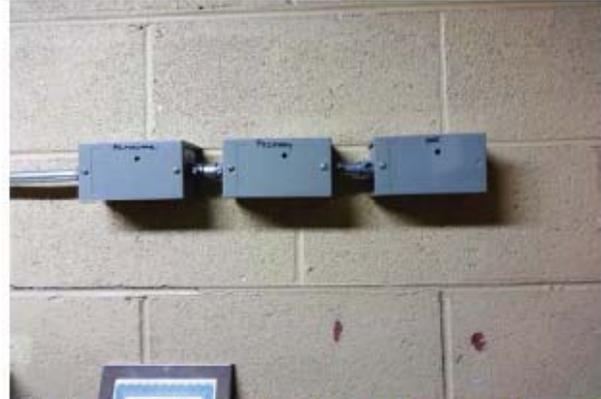
The elevator now has automatic and alternate floor fire recall to meet all current code requirements.

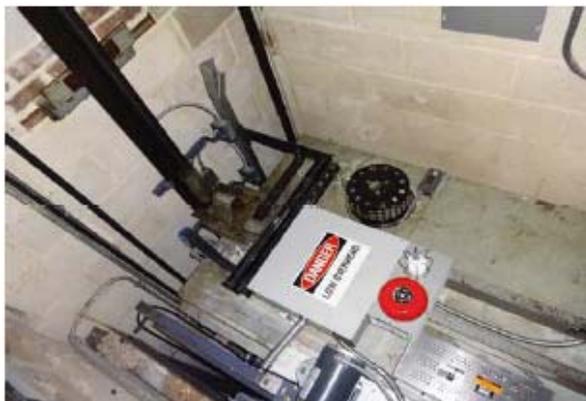
New fan, new lighting, new leveling system. Notice the "Danger - Low Overhead" sign

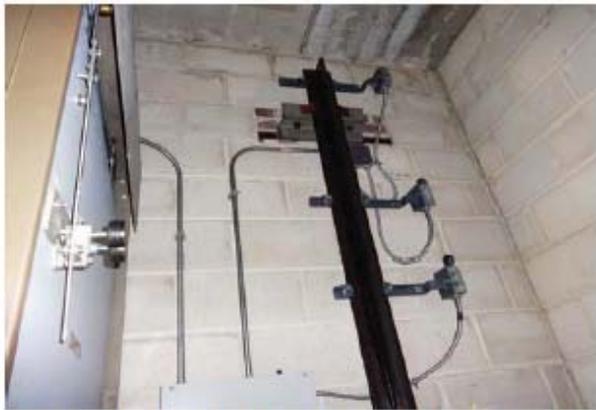
New limit switches on the side wall and note the new hoistway door hardware. A very complete modernization by Colley.

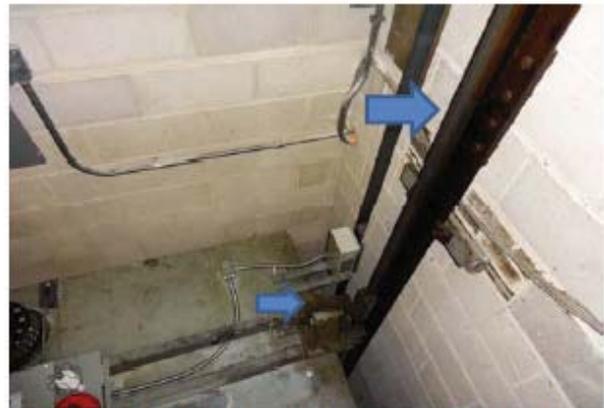
The existing sliding guides were reused. These require the rails to be lubricated. Also, there is a "bump" in the middle of travel (see ride comfort readouts) which is most likely due to this guide hitting an out of alignment rail joint.

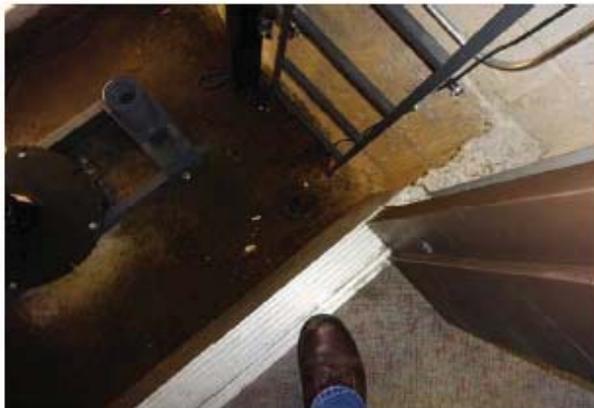
Looking down at the pit drain. The pit area appears damp, but could be from a variety of sources, as there was no standing water. Might even be from when the old cylinder was removed.

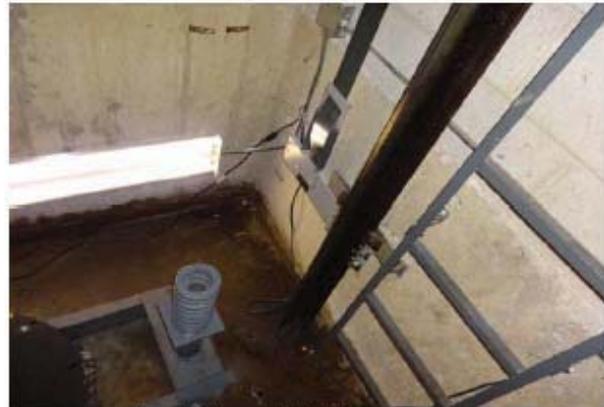
New lighting and pit ladder to meet code.

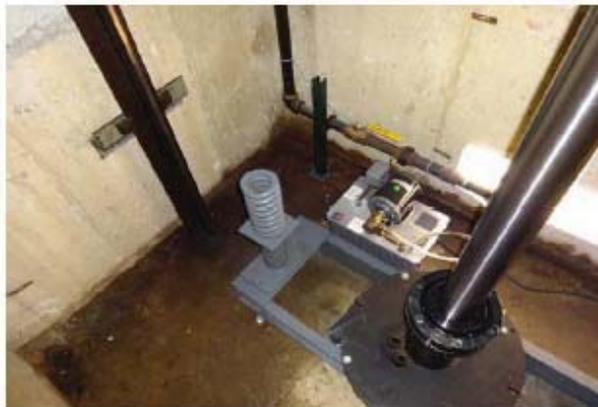
Oil recovery device pumps oil from cylinder head ring back to pump unit on the second floor. Not much oil to pump back from this new cylinder. There will always be a small amount of oil for the piston to move smoothly through the packing.

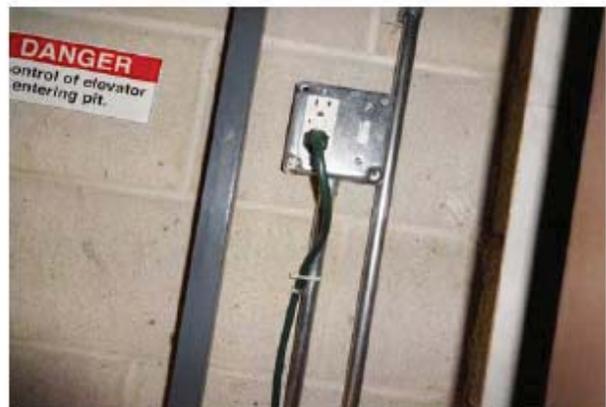
New GFCI protected outlet. Oil recover device is plugged into it.

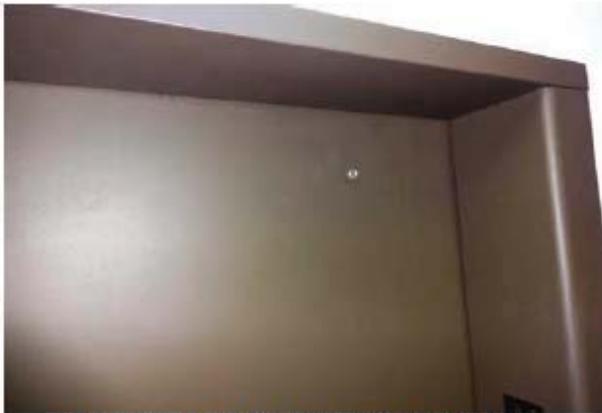
Hoistway doors have emergency evacuation key holes.

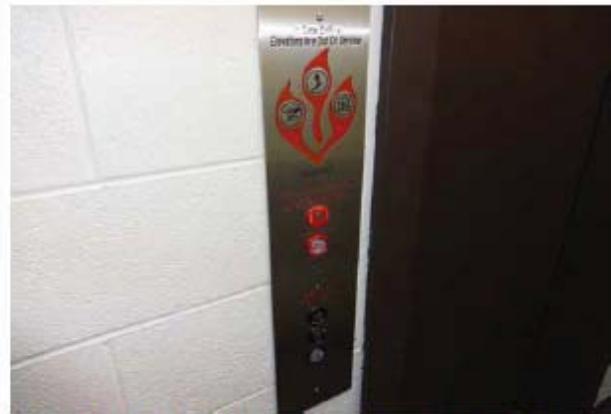
New push button station at the 1st floor contains all current (2010) code required items, including signal in event of elevator telephone system failure.

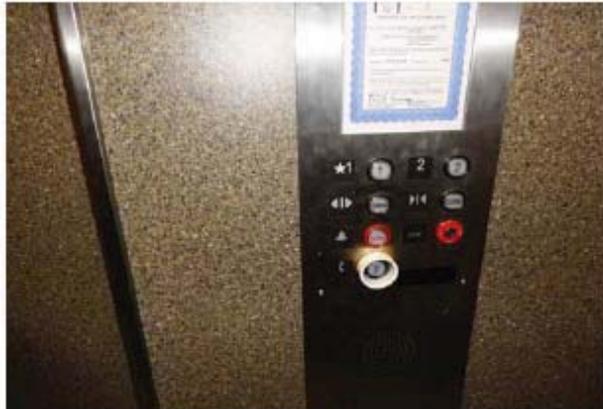
A new car operating panel was installed. The PVC ring around the emergency phone call system is a good idea to minimize accidental contact. We tested the phone - it works as discussed.

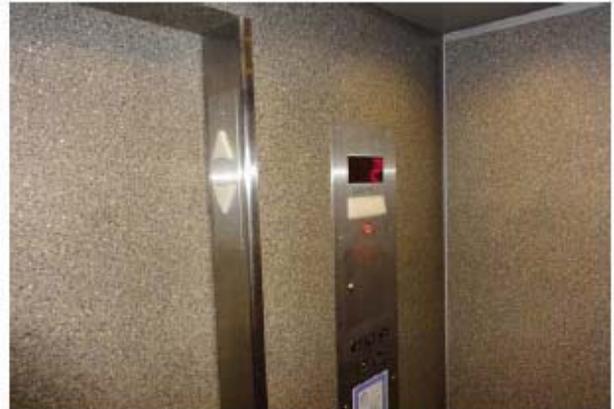
New car fixtures are all code compliant. I didn't notice an audible floor passing signal, but most likely not turned on due to sound as well as there are only two stops.

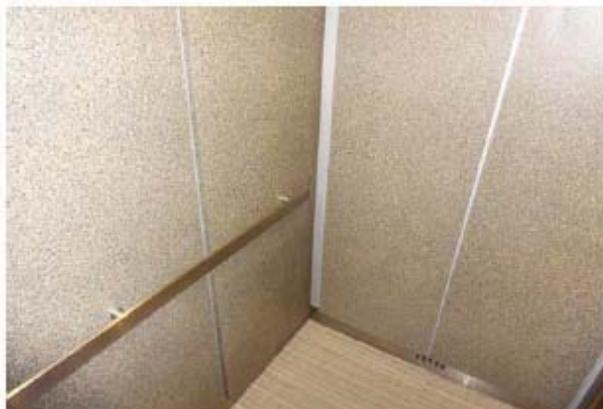
Cab interior turned out nice. ADAAG compliant handrail on the rear wall.

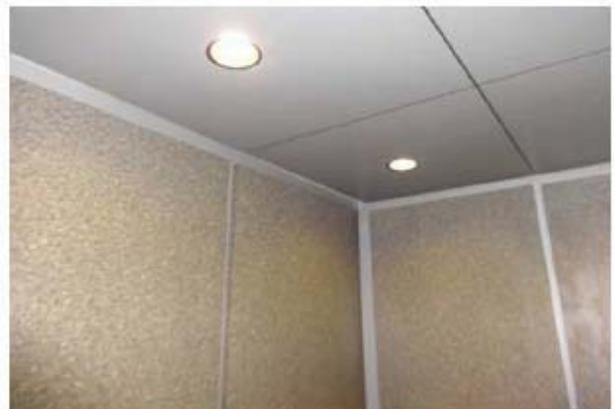
Man-D-Tec LED lighting system throws 15 ft-c of lighting at the cab sill. The emergency lighting system in the car operating panel was also tested. It throws 3 times the code required minimum lighting.

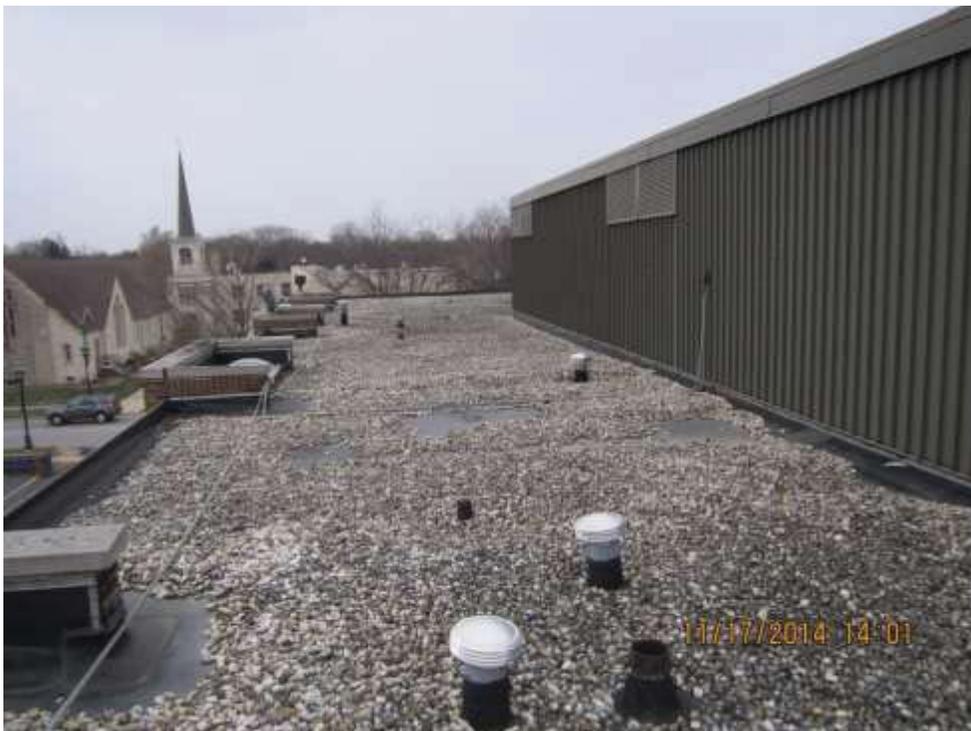
The existing roof system is over 25 years old and is beyond its useful life. The following deficiencies were observed (Refer to Photos 19 - 30):

Photo No. 20. Overall view of roof.

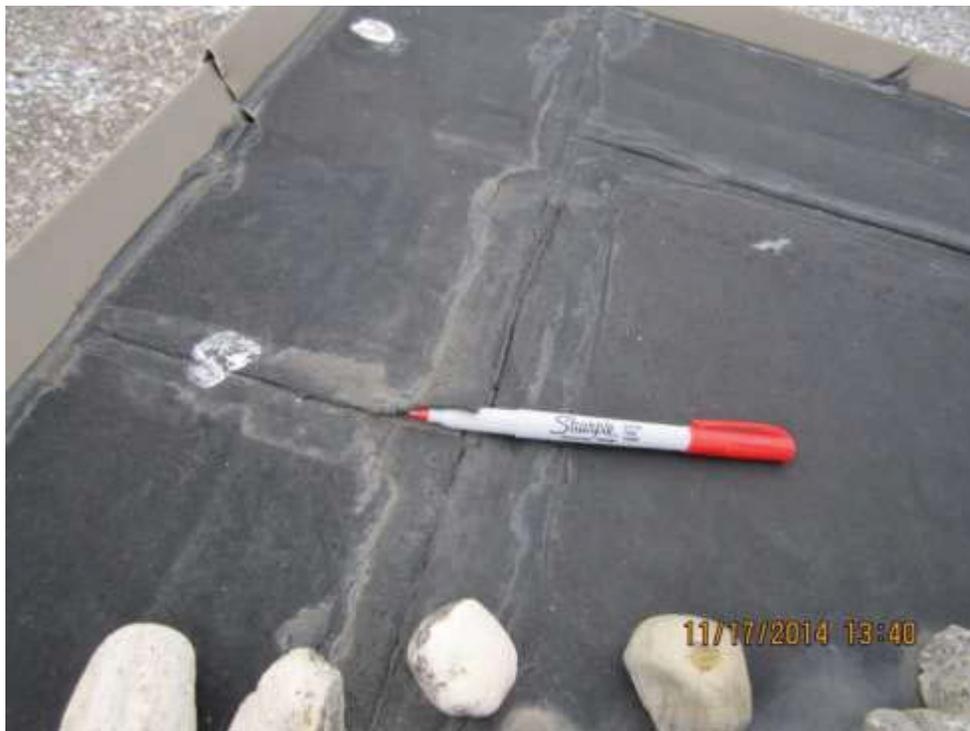
Photo No. 24. Example of open seam.

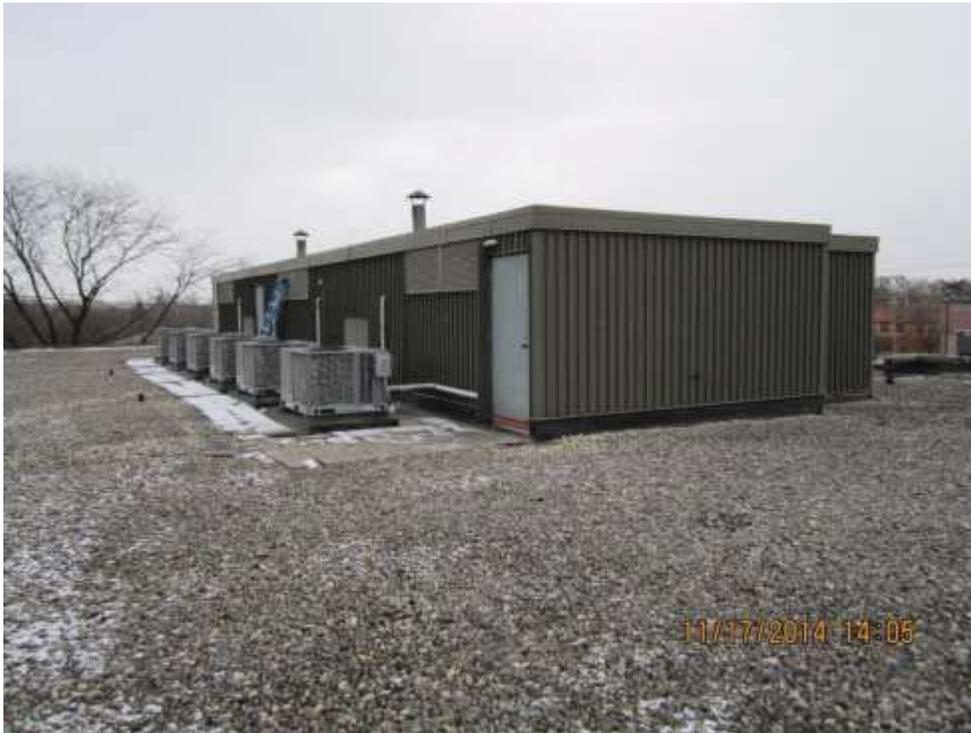
The one-story penthouse is in fair condition with typical loss of paint coating and corrosion of the sheet metal cladding, as well as deterioration of sealant joints. Door penetrations are also in poor condition with low thresholds that prevent proper height of roof flashings. Refer to Photos 31 – 33.

Photo No. 31. View of rooftop penthouse with metal cladding.
